# Waldo Canyon Fire Watershed Assessment: The *WARSSS* Results

**April 5<sup>th</sup>, 2013**

**Dave Rosgen, Brandon Rosgen, Sumner Collins – Wildland Hydrology**

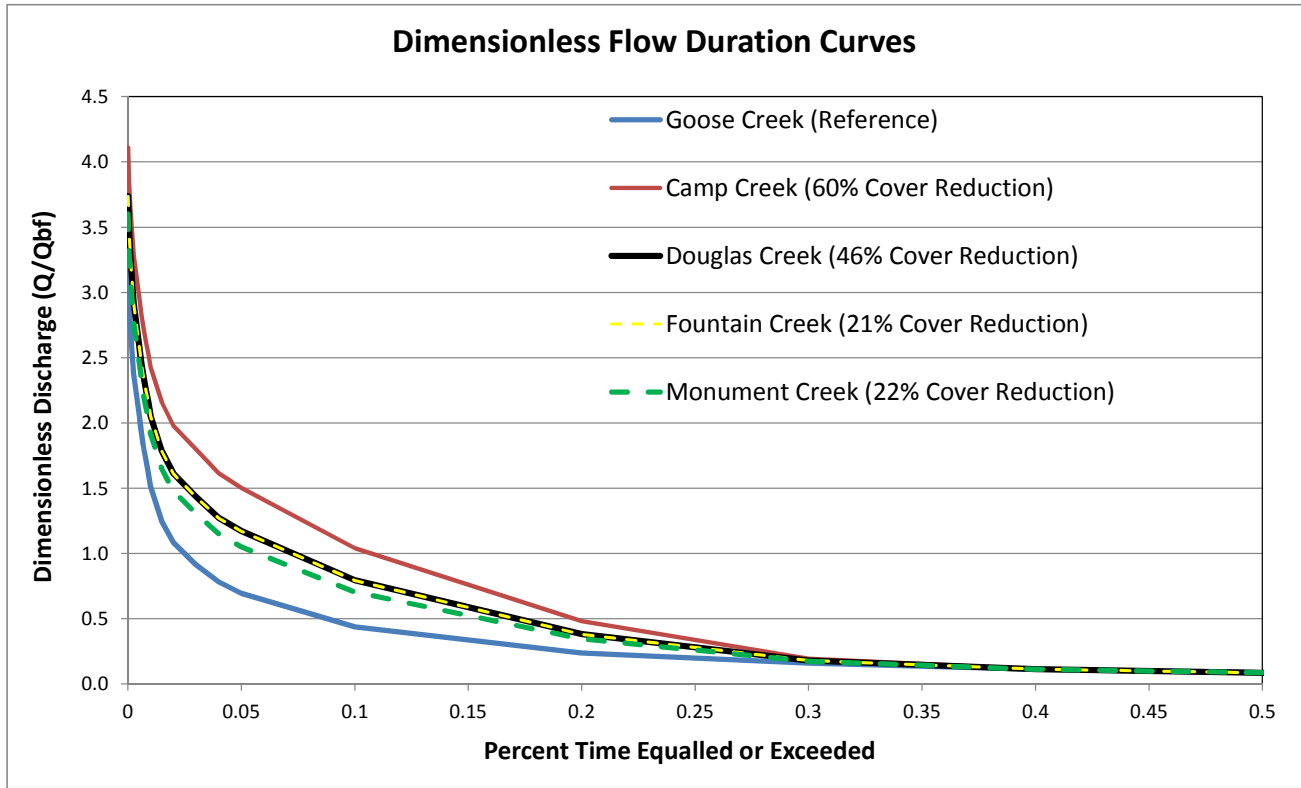
Figure 10. Dimensionless flow-duration curve for the four major watersheds in the Waldo Canyon Fire.

To evaluate the potential flow-related sediment yield increases, the water yield increase data from WRENSS must be converted to dimensionless flow-duration curves normalized by mean daily bankfull discharge. The dimensionless curves are converted to dimensional curves specific to a location. Dimensional flow-duration curves are developed for each watershed and sub-watershed for pre- and post-fire streamflow conditions. A dimensionless flow-duration curve for the major watersheds in the Waldo Canyon Fire is shown in **Figure 10**. The dimensionless flow-duration curve for the major watersheds reflects the burn area. In Camp Creek, Douglas Creek, and West Monument Creek, the watersheds affected by the burn represented a majority of the total area. Douglas Creek combines North and South Douglas Creeks. The water yield change in Fountain Creek is distributed over the entire watershed area where the burn only influences 63% of the watershed area resulting in a lower total annual water yield change (**Table 3**). This dimensionless curve was then converted to a dimensional flow-duration curve using mean daily bankfull discharge as shown in **Figures 11–14** for each major watershed. For the remainder of the analysis, the sum of the sub-watersheds influenced by the burn is used.

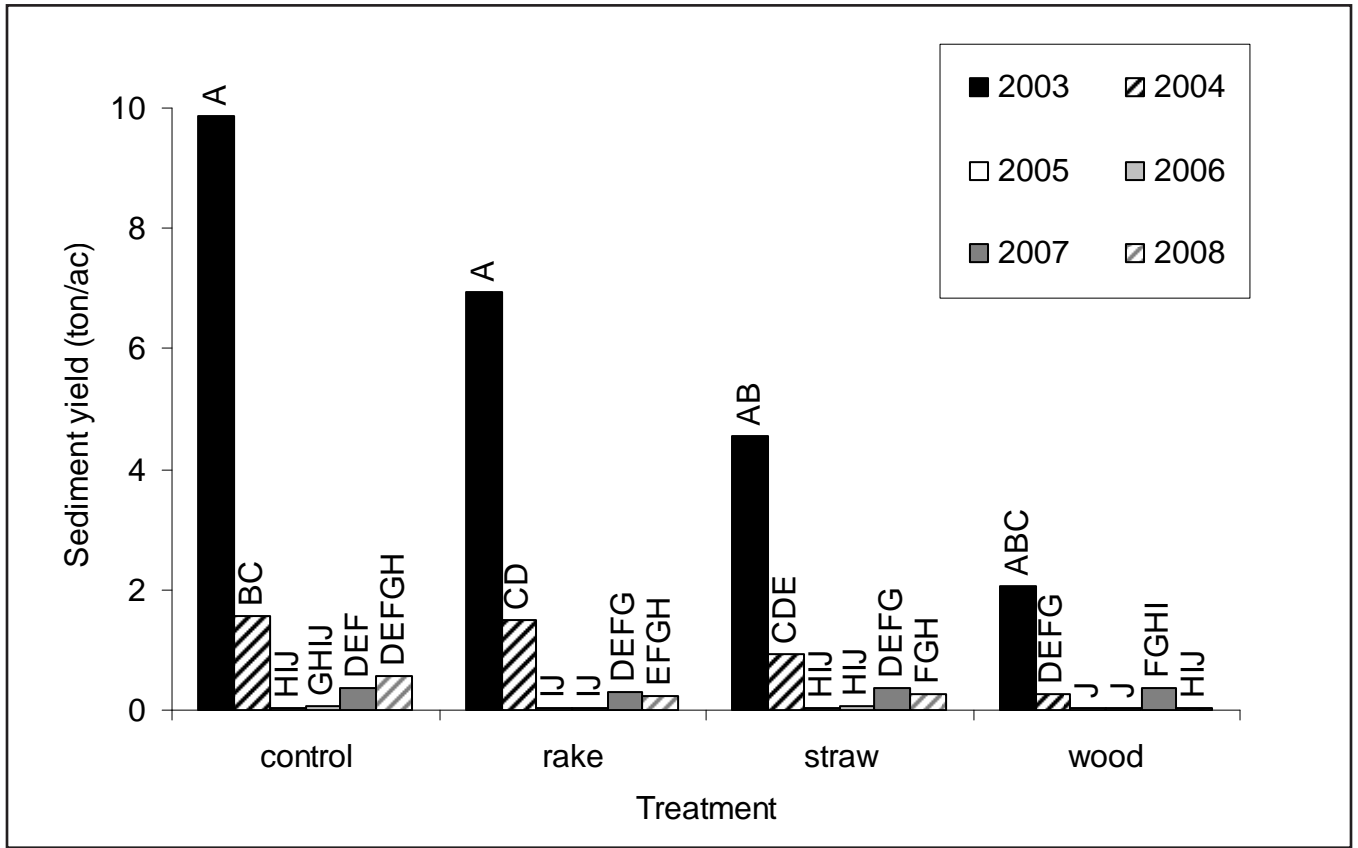
**Figure 15.** Sediment yield measurements (tons/acre/yr) over time from surface erosion study plots showing sediment reduction over time from 2002 to 2008, Hayman wildfire (reproduced from Robichaud & Wagenbrenner, 2009).

Robichaud and Wagenbrenner (2009) reported that increasing ground cover led to a major reduction in surface erosion source sediment yield between 2002 and 2008 in the Hayman burn area (**Figure 15**). The result of the reduced sediment yield from surface erosion is shown by corresponding changes in the percent of ground cover (**Figure 16**). For slopes in the 15–40% range and for ground cover greater than 50%, limited sediment yields from surface erosion is anticipated based on data six years following the fire. Sediment yields were greatly reduced from the initial erosion and sedimentation rates by 2008, even in the presence of high intensity rainstorms. Based on the conducted research, it may be inferred that the highest potential for sediment yields from surface erosion are more likely to occur adjacent to stream systems on very steep slopes with less than 20% ground coverage. As stated by MacDonald (2009), hillslope processes (other than roads and ORV trails) do not contribute the bulk of the sediment yield from the Hayman Fire.

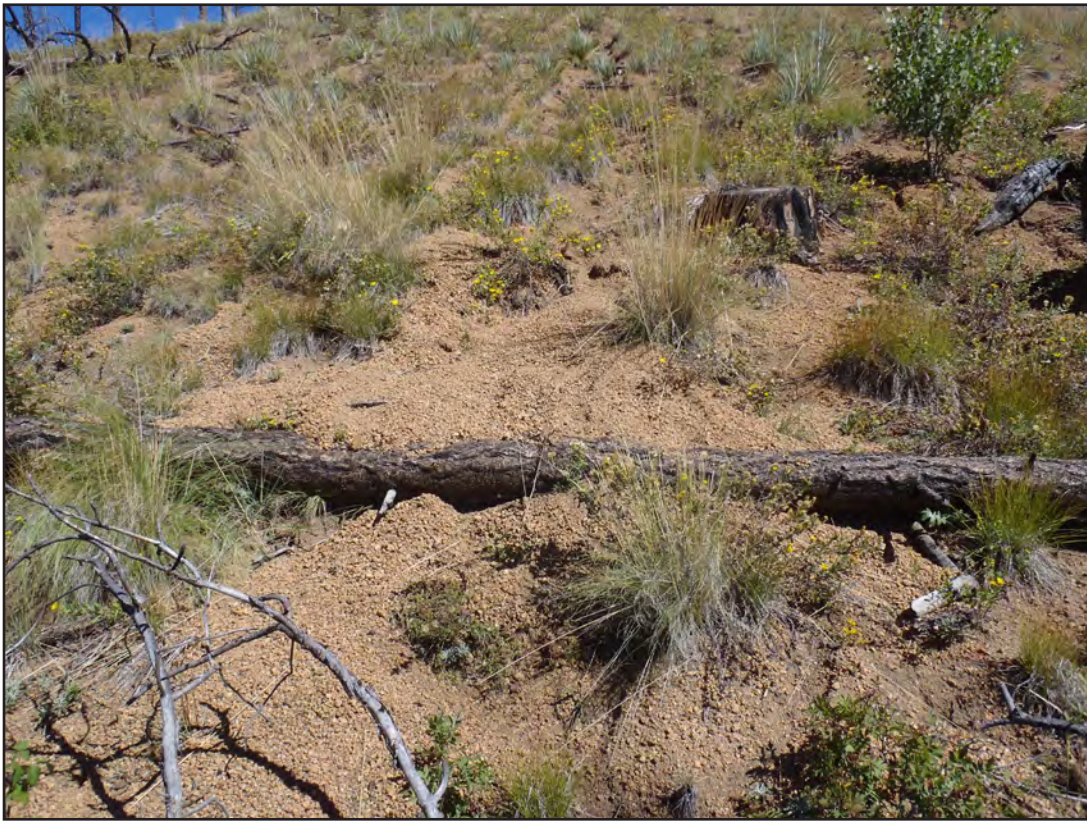
**Figure 18.** Deposition of sediment from surface erosion behind logs and vegetation on slopes greater than 40% with high burn intensity, which provide low sediment delivery to stream channels.

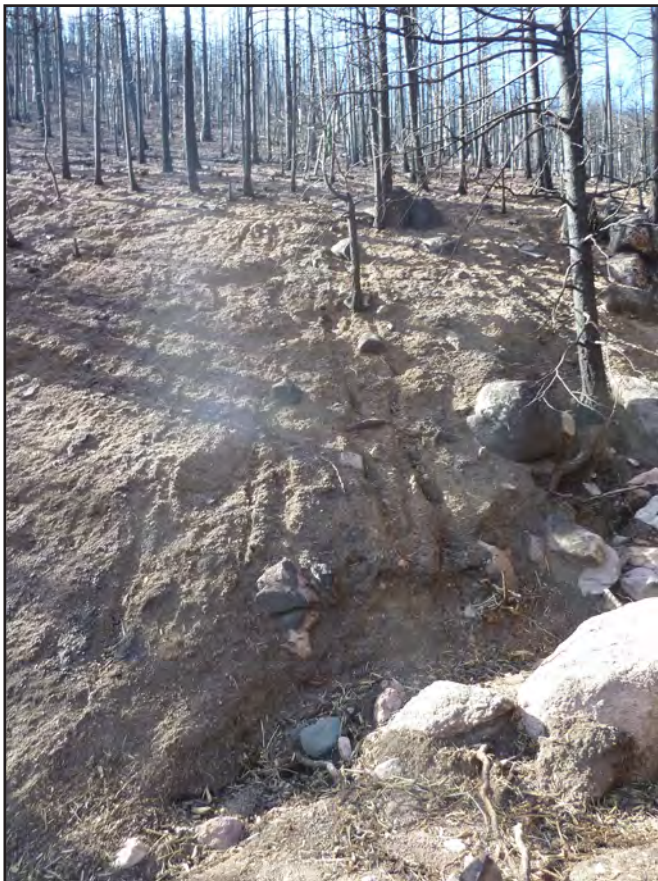
**Figure 19.** Surface erosion on exposed slope adjacent to DC-007 showing rills and transported soils associated with a very low ground cover density.

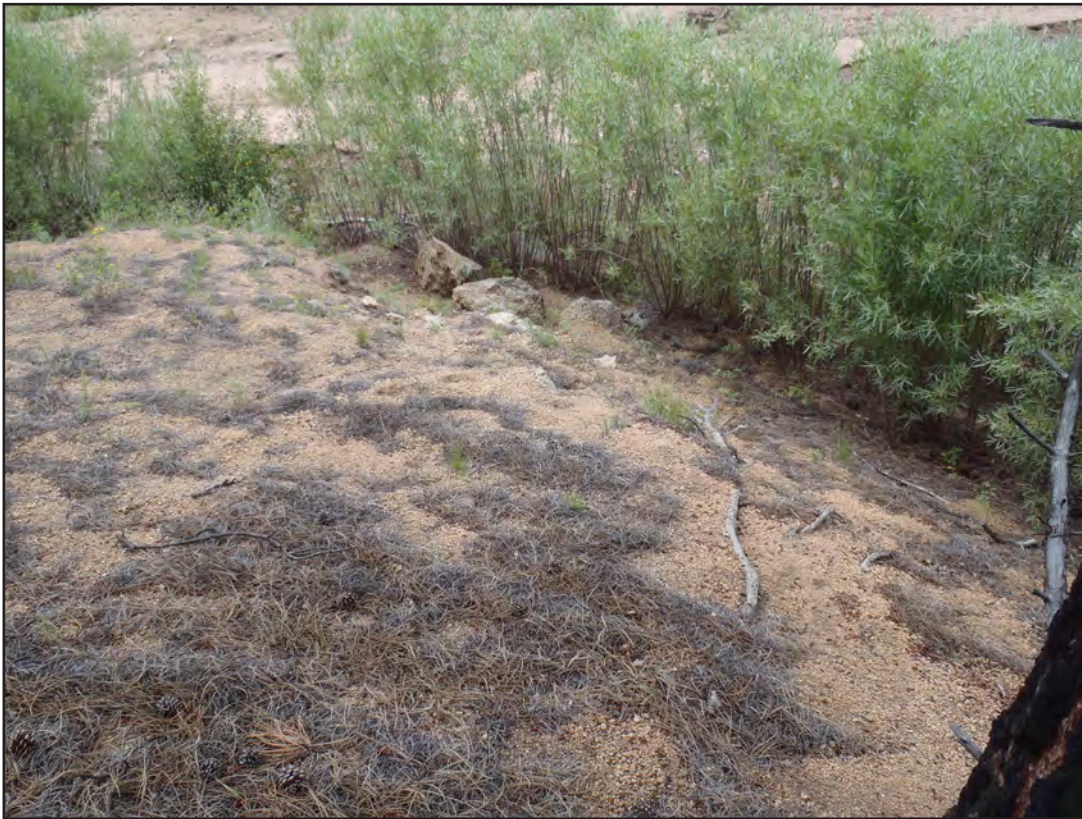
**Figure 20.** Effective trap of eroded soil at the toe of an actively eroding slope due to a bankfull bench and riparian vegetation.

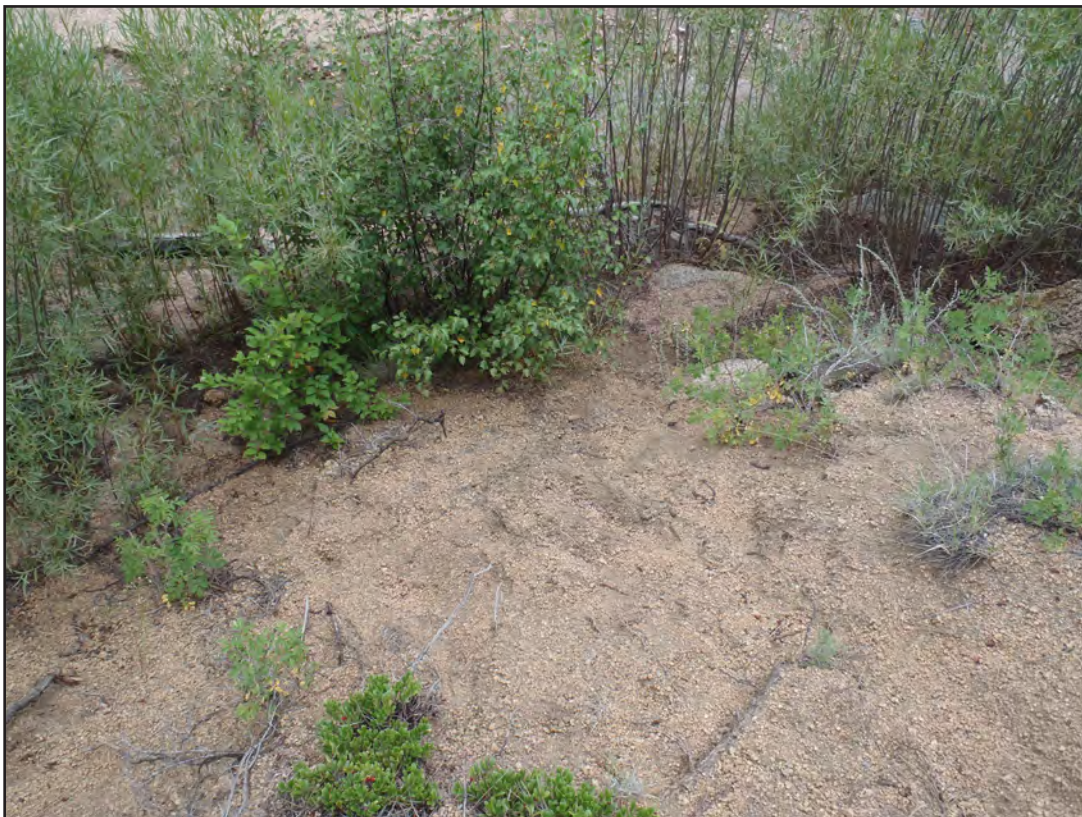
**Figure 21.** Close-up view of the effectiveness of the bankfull bench and riparian vegetation at preventing soil from entering stream.

- Figure 20.** Effective trap of eroded soil at the toe of an actively eroding slope due to a bankfull bench and riparian vegetation.
- Figure 21.** Close-up view of the effectiveness of the bankfull bench and riparian vegetation at preventing soil from entering Trail Creek.

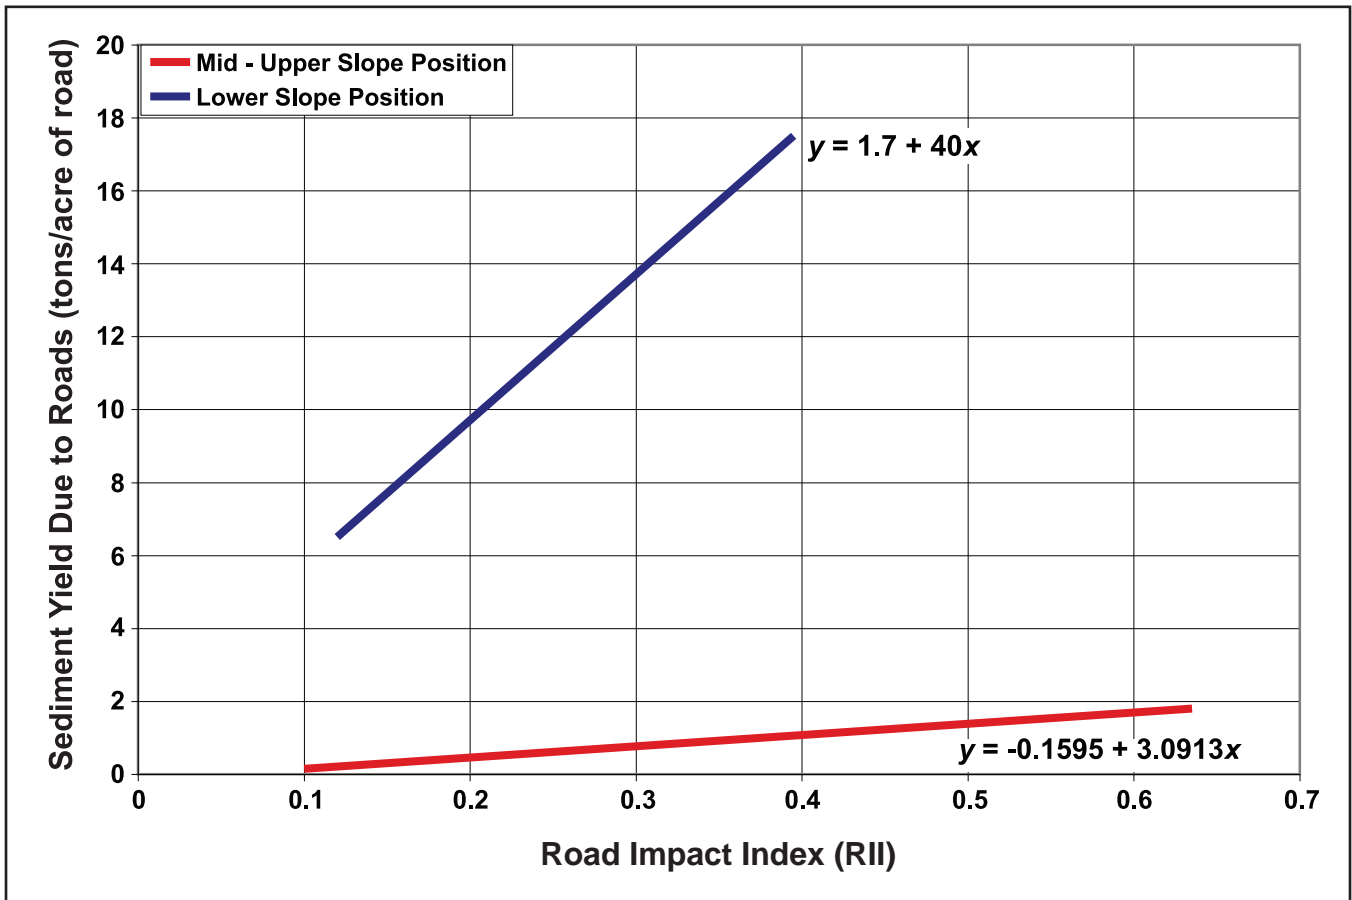
**Figure 22.** Sediment yield from roads based on the Road Impact Index (RII) stratified by slope position (WARSSS, Rosgen, 2006/2009).

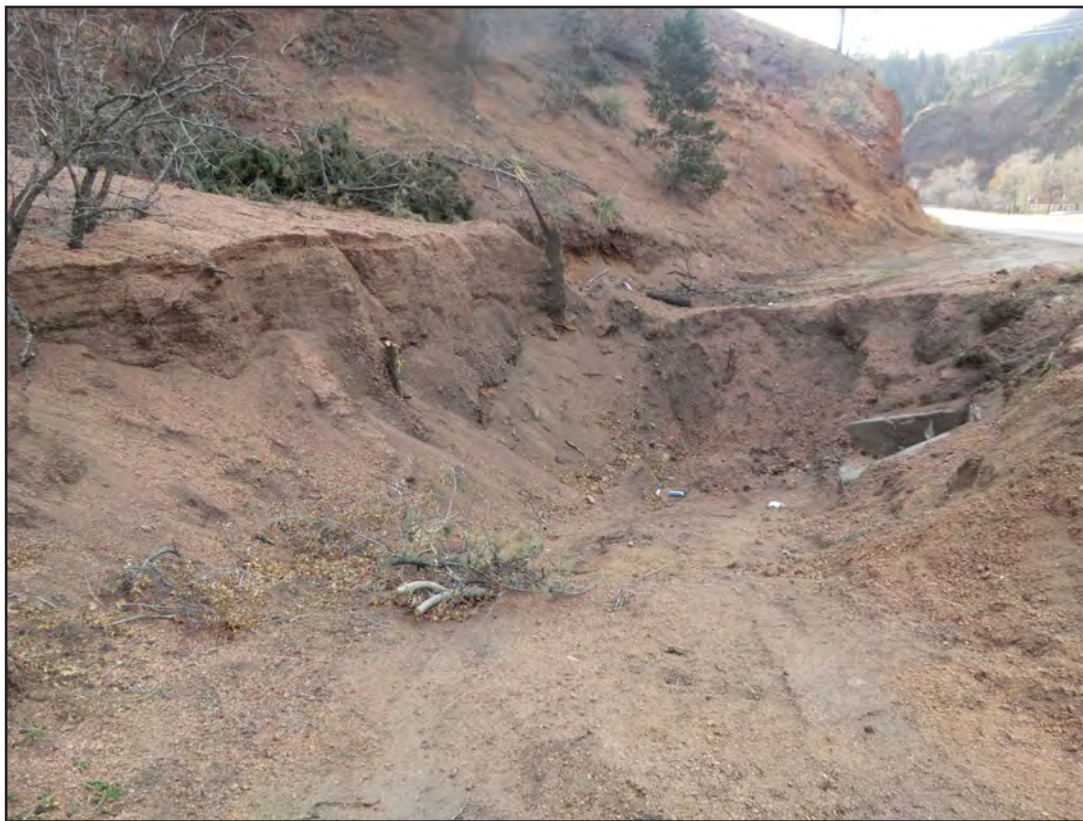
**Figure 23.** Cleaning out drainage structures continues to cut through depositional surfaces and cause headcut migration.

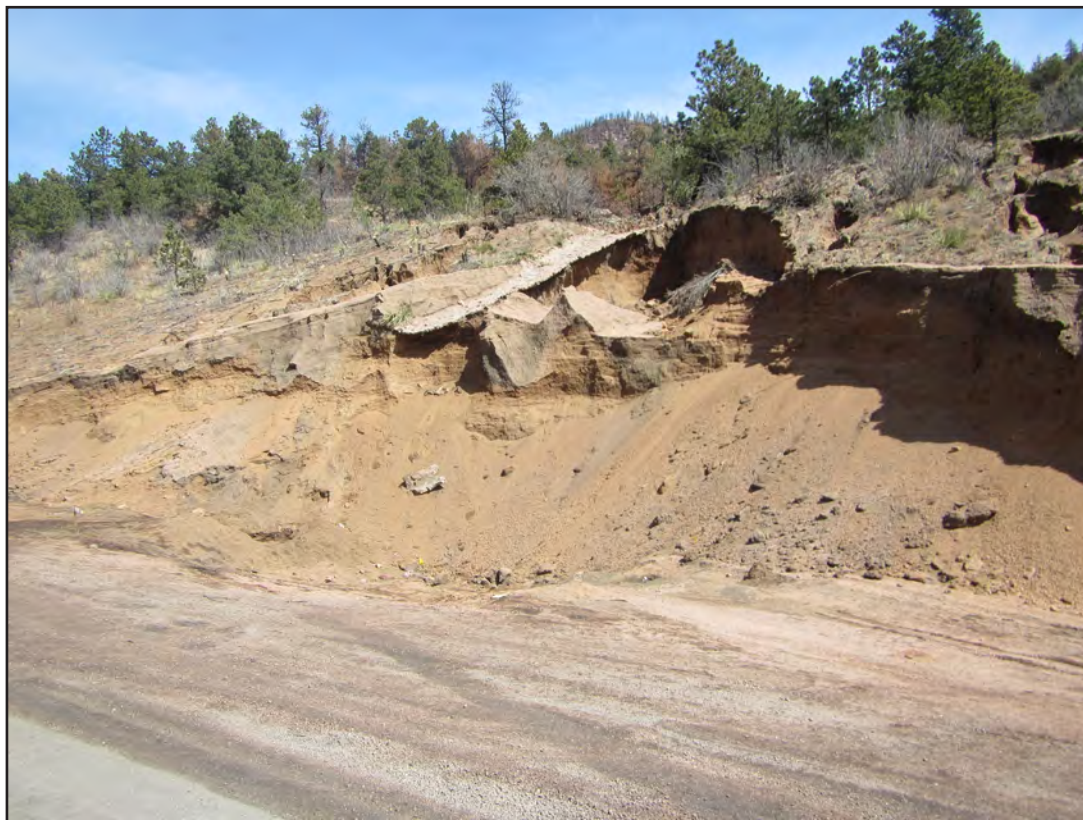
**Figure 24.** Road with a cut off fan accelerating erosion.

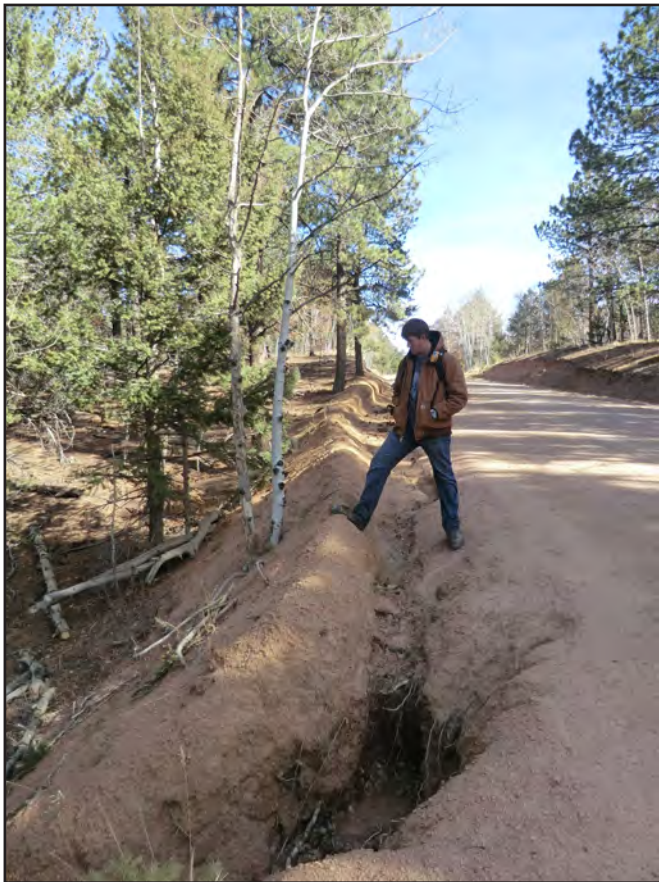
**Figure 25.** Road ditch with berm delivering sediment into stream channel.

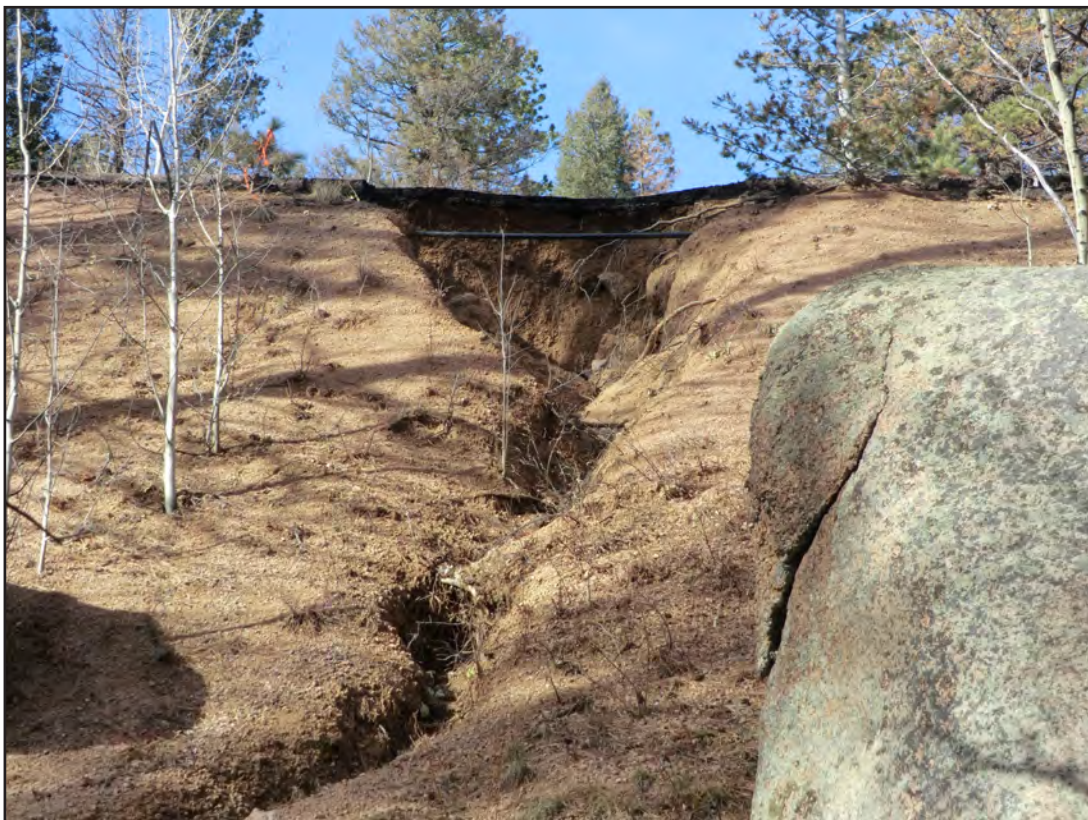
**Figure 26.** Headcut from poor drainage causing excess erosion below road.

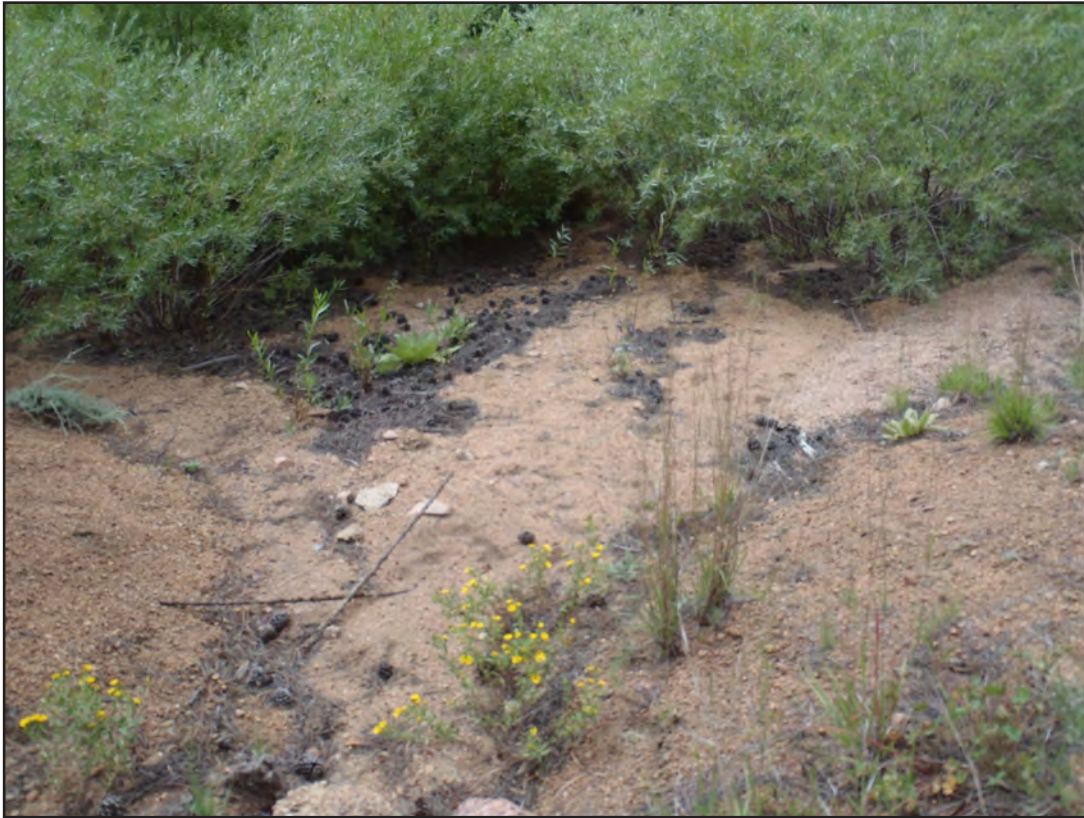
**Figure 27.** Small alluvial fan deposit showing stable, functioning fan and a D4 stream type at the toe of a slope as the deposit is spread onto floodplain surface preventing direct introduction of sediment.

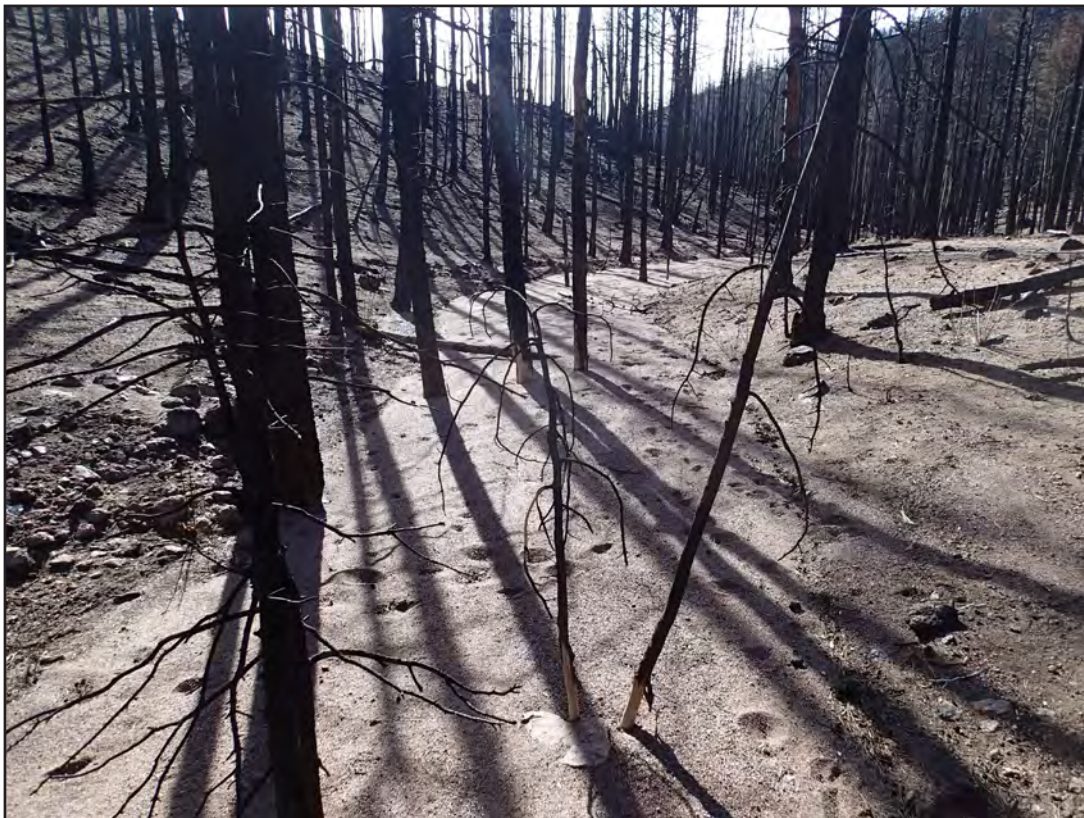
**Figure 28.** A stable, functioning, braided, D4 stream type on an alluvial fan (Valley Type IIIb), Douglas Creek.

- Figure 28.** A stable, functioning, braided, D4 stream type on an alluvial fan (Valley Type IIIb), Douglas Creek.
- Figure 29.** Vegetated alluvial fan that is effectively trapping sediment from an ephemeral D4 stream type.

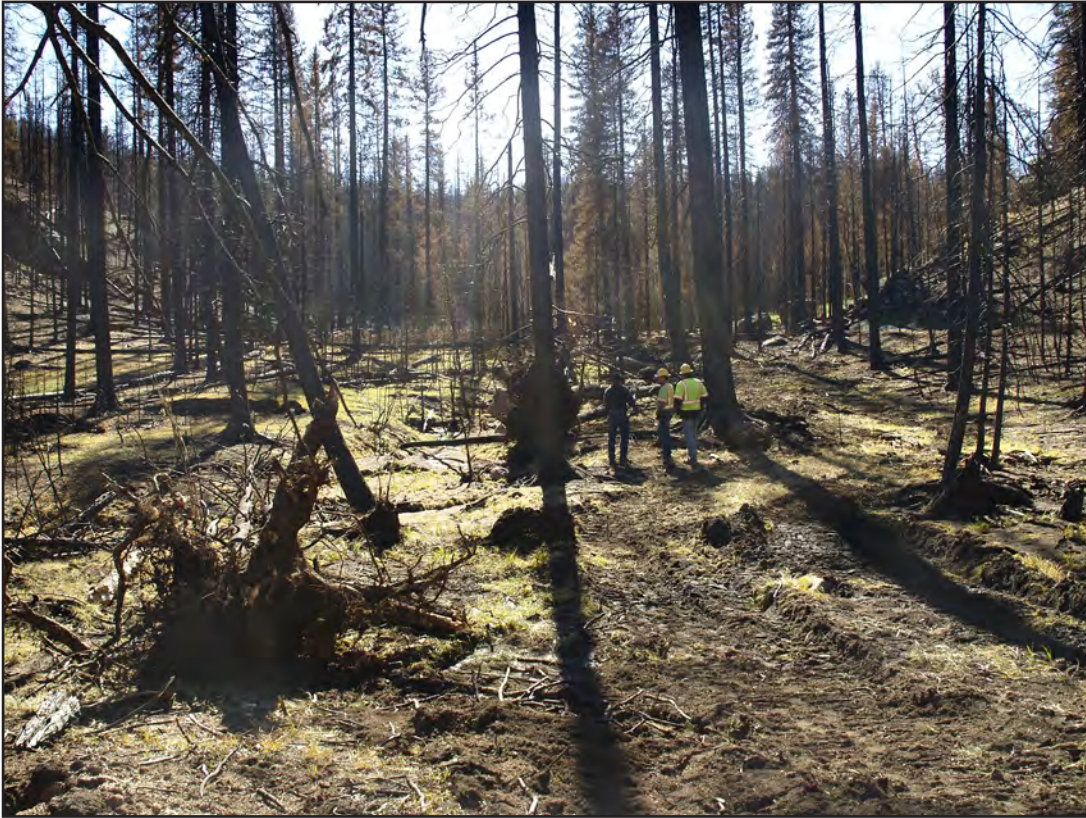
**Figure 29.** Vegetated alluvial fan that is effectively trapping sediment from an ephemeral D4 stream type, Northfield Gulch.

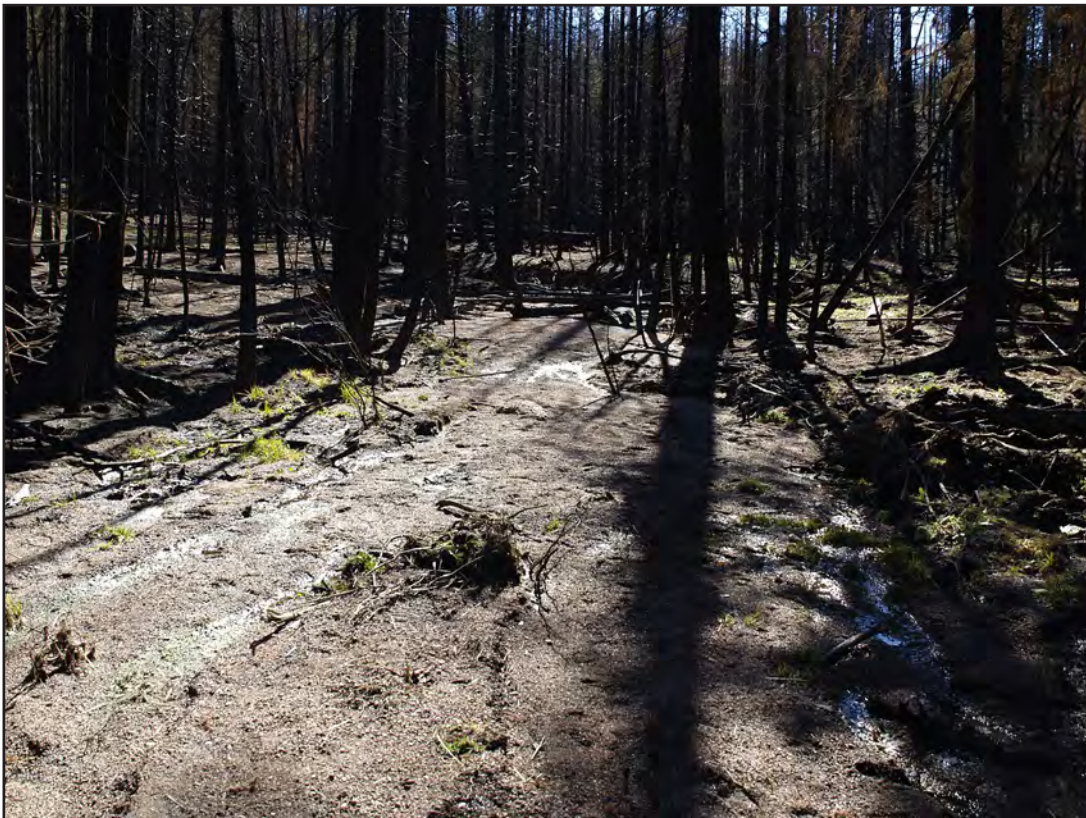
**Figure 30.** A functioning, braided, D4 stream type on an alluvial fan that is depositing sediment rather than the sediment being routed into Northfield Gulch.

- Figure 30.** A functioning, braided, D4 stream type on an alluvial fan that is depositing sediment rather than the sediment being routed into Northfield Gulch.

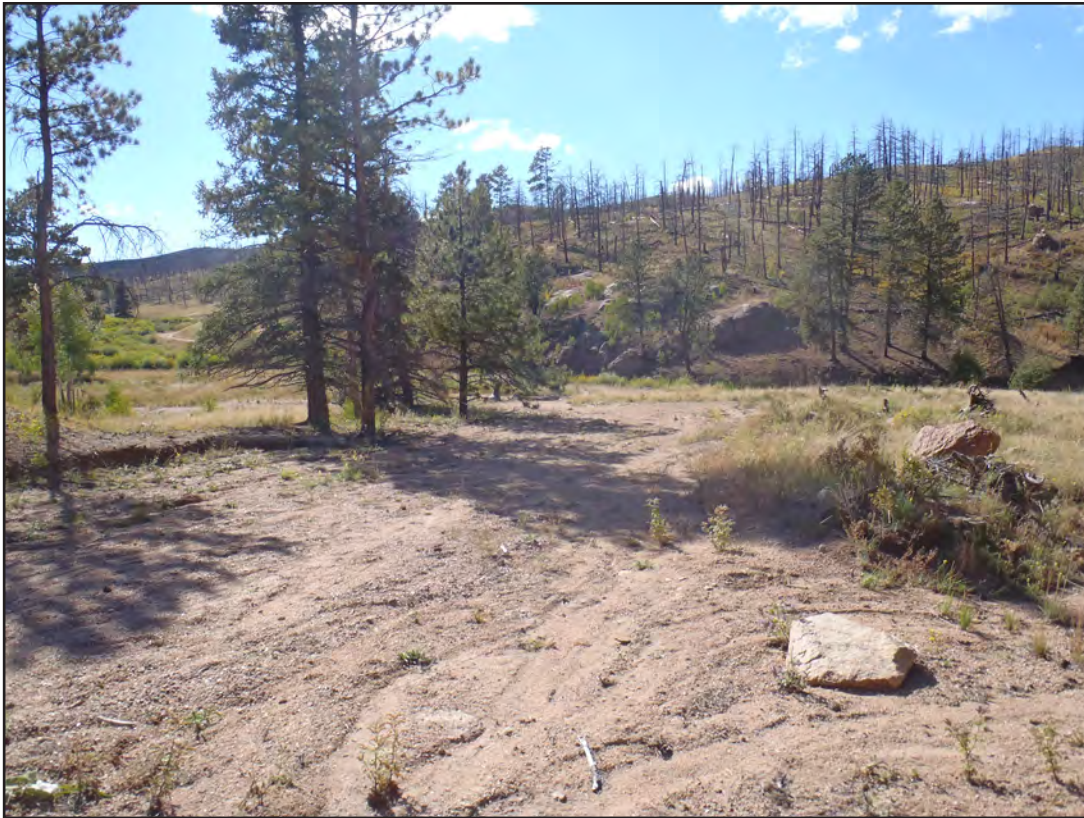
**Figure 31.** A large tributary and functioning alluvial fan with a D4 stream type that is depositing excess sediment onto the active fan surface.

- Figure 31.** A large tributary and functioning alluvial fan with a D4 stream type that is depositing excess sediment onto the active fan surface.

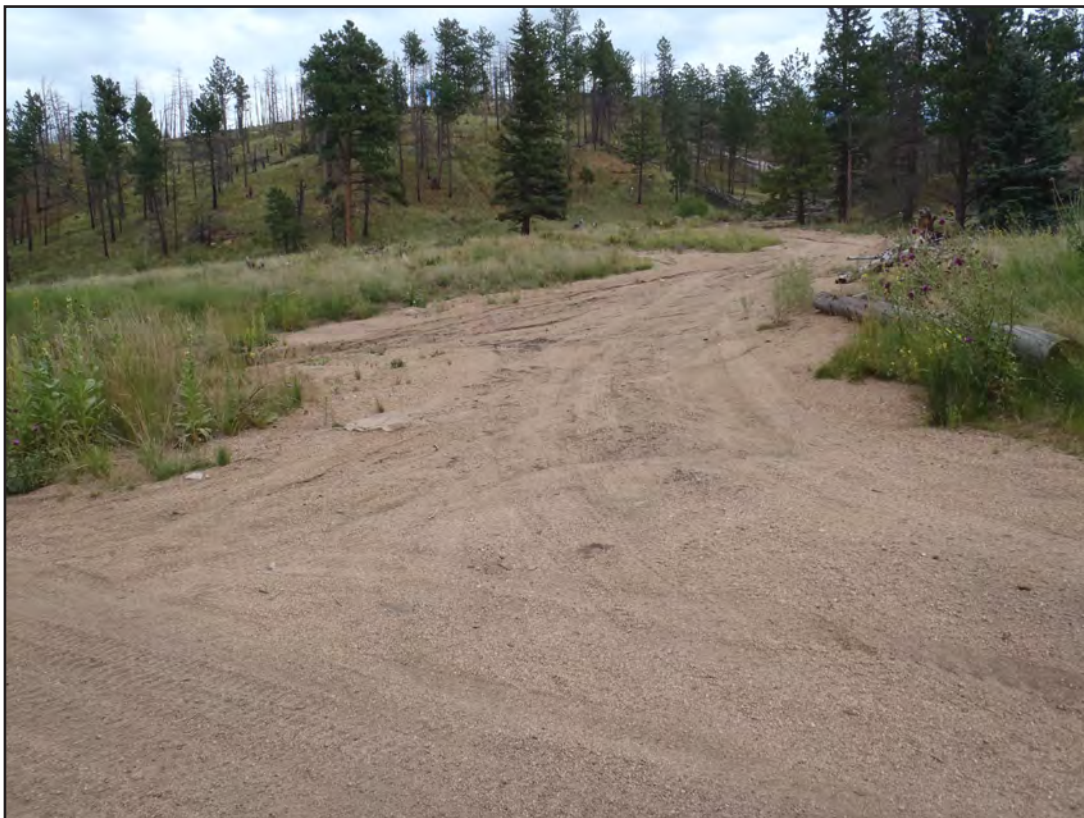
**Figure 32.** A braided, D4 stream type that is depositing sediment onto a fan rather than effectively routing sediment into trunk stream.

- Figure 32.** A braided, D4 stream type that is depositing sediment onto a fan rather than effectively routing sediment into trunk stream.
- Figure 33.** Various stream succession scenarios and corresponding stages of adjustment (Rosgen, 2006/2009).

The function of alluvial fans are to naturally store sediment directly below high sediment supply and high transport stream types, such as A3a+, A4a+, A5a+, A3–A5, F3–F5, and G3–G5 stream types (see **Appendix B** for stream type descriptions). The stable stream type for actively building, alluvial fans are the braided, D3–D5 stream types. The braided channel types disperse flow by convergence/divergence bed feature processes and induce sediment deposition over the width and length of the fan. Small to large alluvial fans are shown in **Figures 27–32** depicting the sediment deposited from upstream, high sediment supply stream types onto the extensive fan surface associated with braided, D4 stream types.

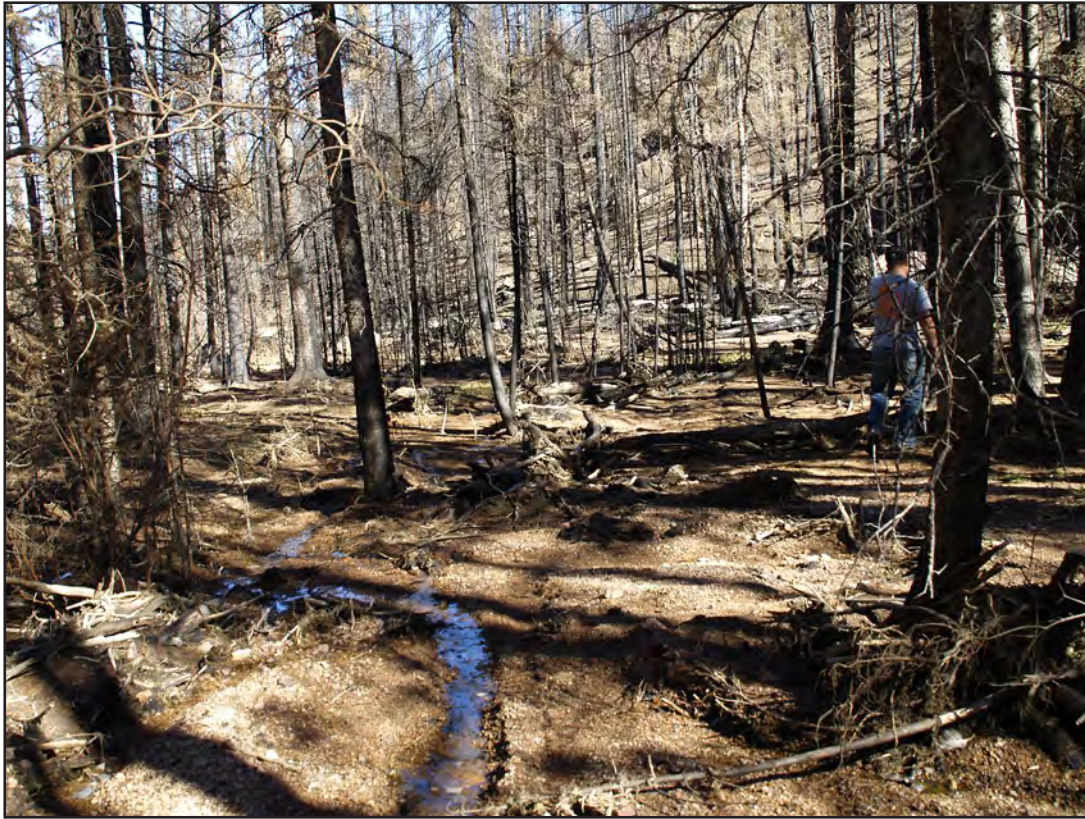
**Figure 34.** A gravel-bed, braided, D4 stream type showing a very high width/depth ratio and excess bar deposition on Northfield Gulch.

- Figure 34.** A gravel-bed, braided, D4 stream type showing a very high width/depth ratio and excess bar deposition on Northfield Gulch.
- Figure 35.** An entrenched and actively incising gravel-bed gully, G4 stream type, downcut in previously deposited material in Northfield Gulch. Note the very high sediment supply from both streambed and banks.

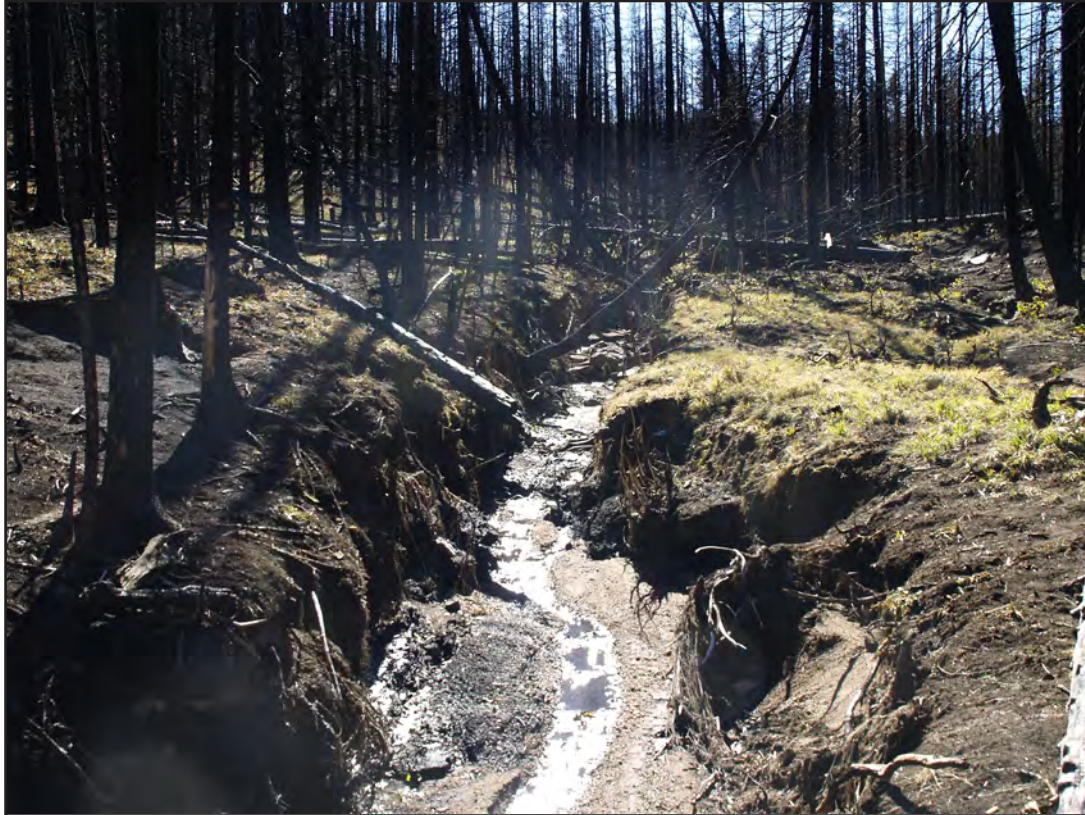
**Figure 35.** An entrenched and actively incising gravel-bed gully, G4 stream type, downcut in previously deposited material in Northfield Gulch. Note the very high sediment supply from both streambed and banks.

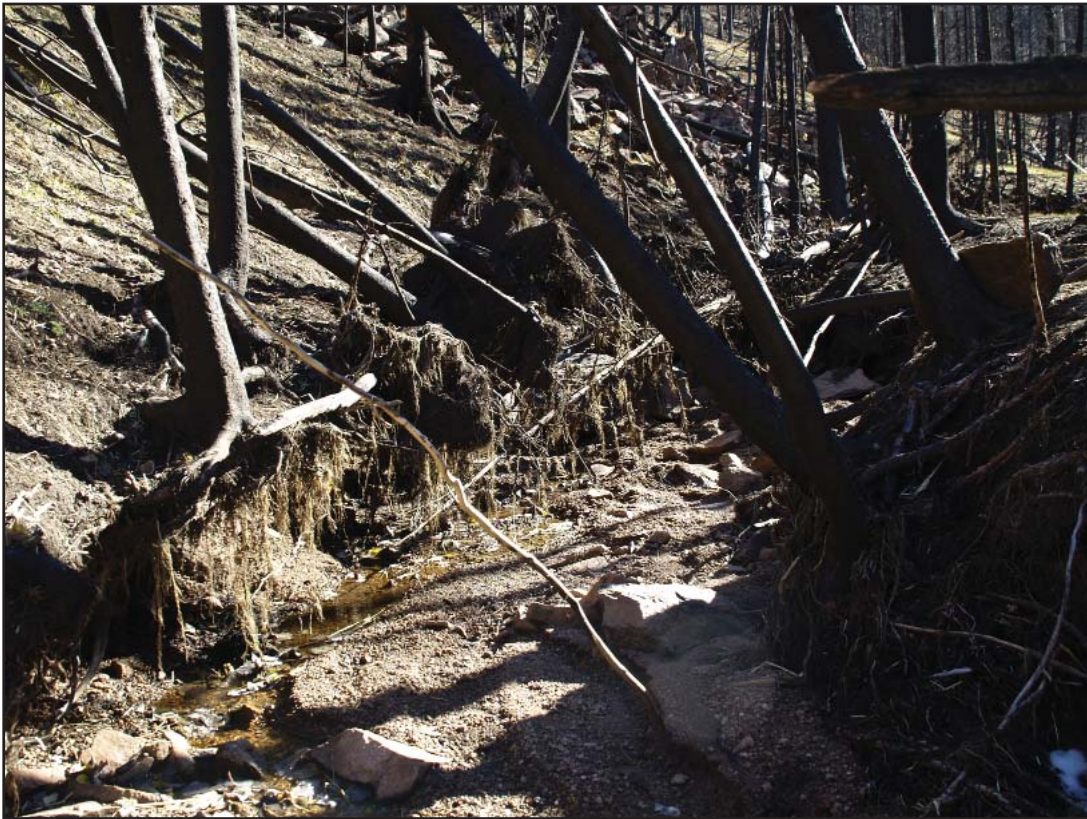
**Figure 36.** An entrenched and actively enlarging F4 stream type with a high width/depth ratio, bar deposition and accelerated streambank erosion, Northfield Gulch.

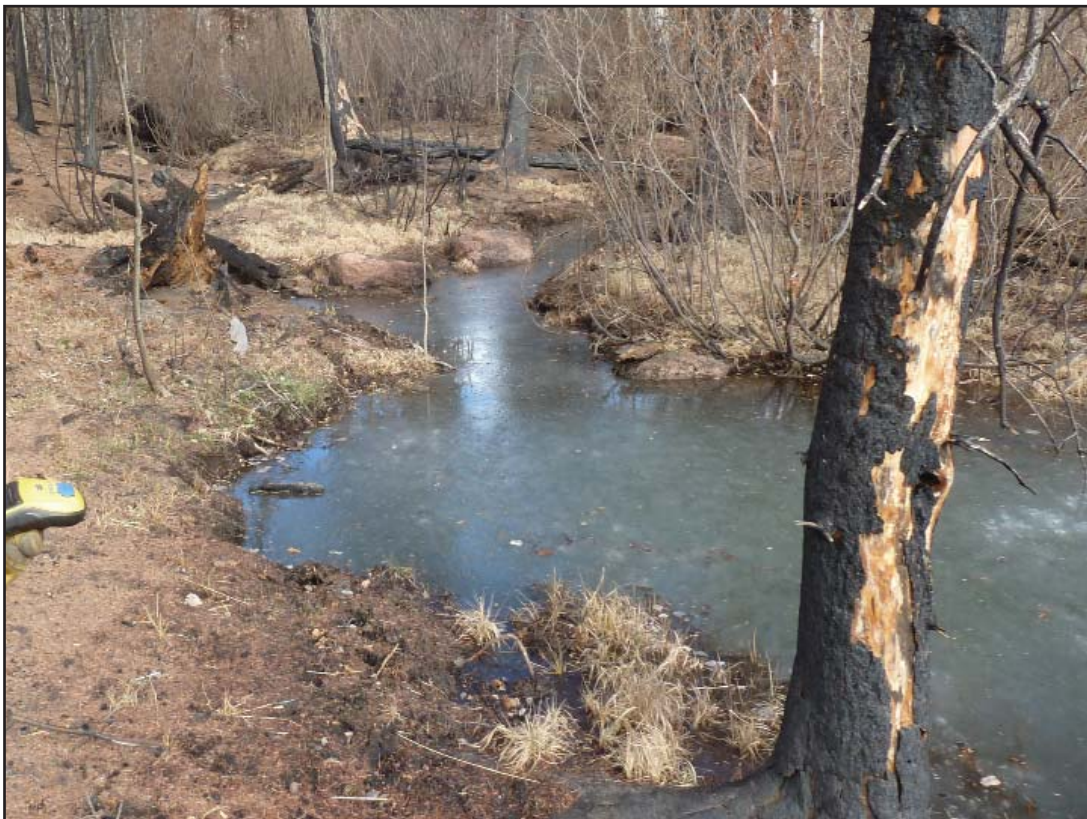
**Figure 37.** A meandering, gravel-bed, C4 stream type, developing a new floodplain on an abandoned bed surface of a D4 stream type, Camp Creek.

- Figure 37.** A meandering, gravel-bed, C4 stream type, developing a new floodplain on an abandoned bed surface of a D4 stream type, Camp Creek.
- Figure 38.** An entrenched and actively incising gravel-bed gully, G4 stream type, downcut in previously deposited material, Northfield Gulch (MC-010). Note the very high sediment supply from streambed and banks.

*Stream type succession* is used to interpret and predict the potential stable morphological state. Sixteen stream succession scenarios and stream type shifts toward stable end points for each scenario are presented in **Figure 33** (Rosgen, 2006/2009). These scenarios represent various sequences from actual rivers and are used to assist in predicting a river's behavior based on documentation of similar response from similar types for imposed conditions. Note that more scenarios exist than the sixteen depicted. It is important to select the appropriate scenario and current stage of stream succession to assist in selecting the stable, end-point stream type for restoration. Scenario #3, associated with the C4 to D4 to G4 to F4 to C4 stream type succession (**Figure 33**), is occurring in Northfield Gulch as depicted in **Figure 34** (D4 stream type), **Figure 35** (G4 stream type), and **Figure 36** (F4 stream type). The stable end-point, meandering, C4 stream type is depicted in **Figure 37**.

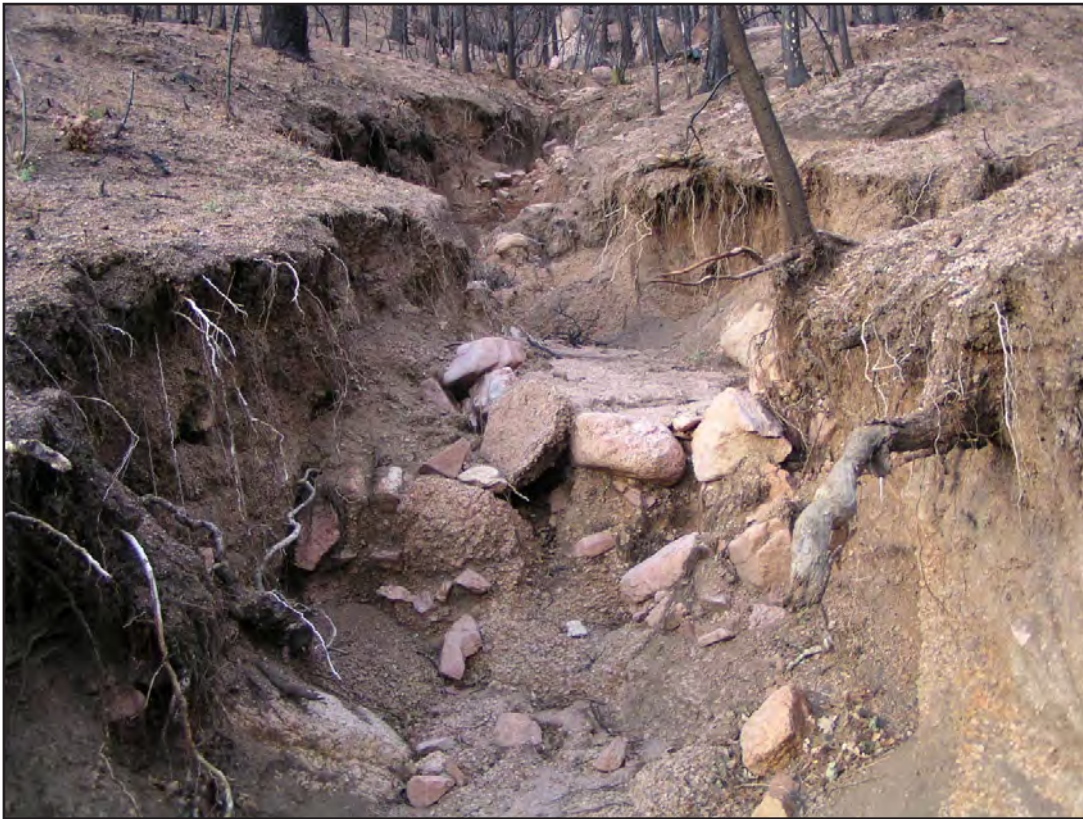
**Figure 38.** An entrenched and actively incising gravel-bed gully, G4 stream type, downcut in previously deposited material, Northfield Gulch (MC-010). Note the very high sediment supply from streambed and banks.

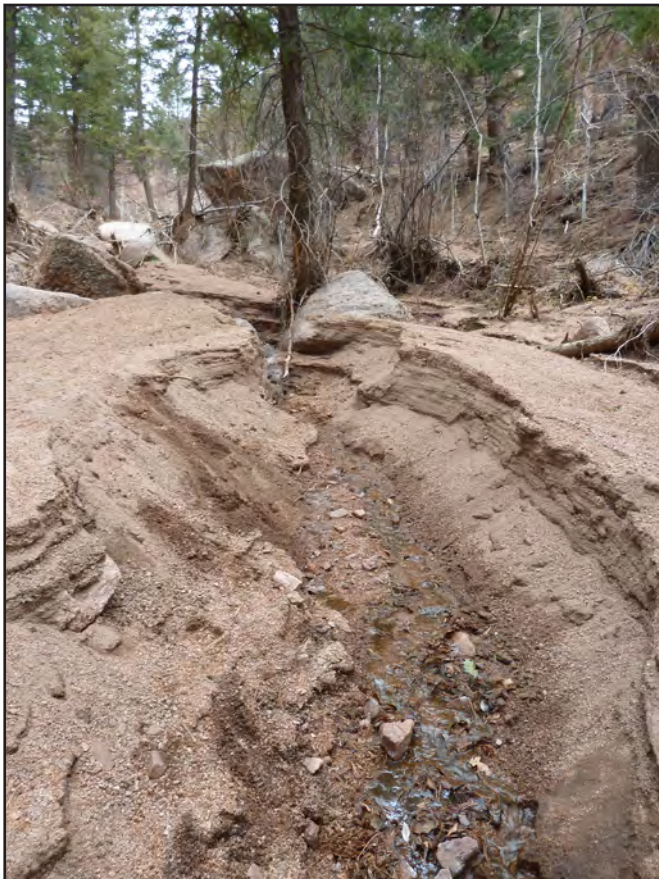
**Figure 39.** An actively incising and widening gully G4 stream type, Sand Gulch (FC-011). Increases in streamflow peaks show unlimited, high sediment supply from channel erosion processes.
