# Waldo Canyon Fire Watershed Assessment: The *WARSSS* Results

**April 5<sup>th</sup>, 2013**

**Dave Rosgen, Brandon Rosgen, Sumner Collins – Wildland Hydrology**

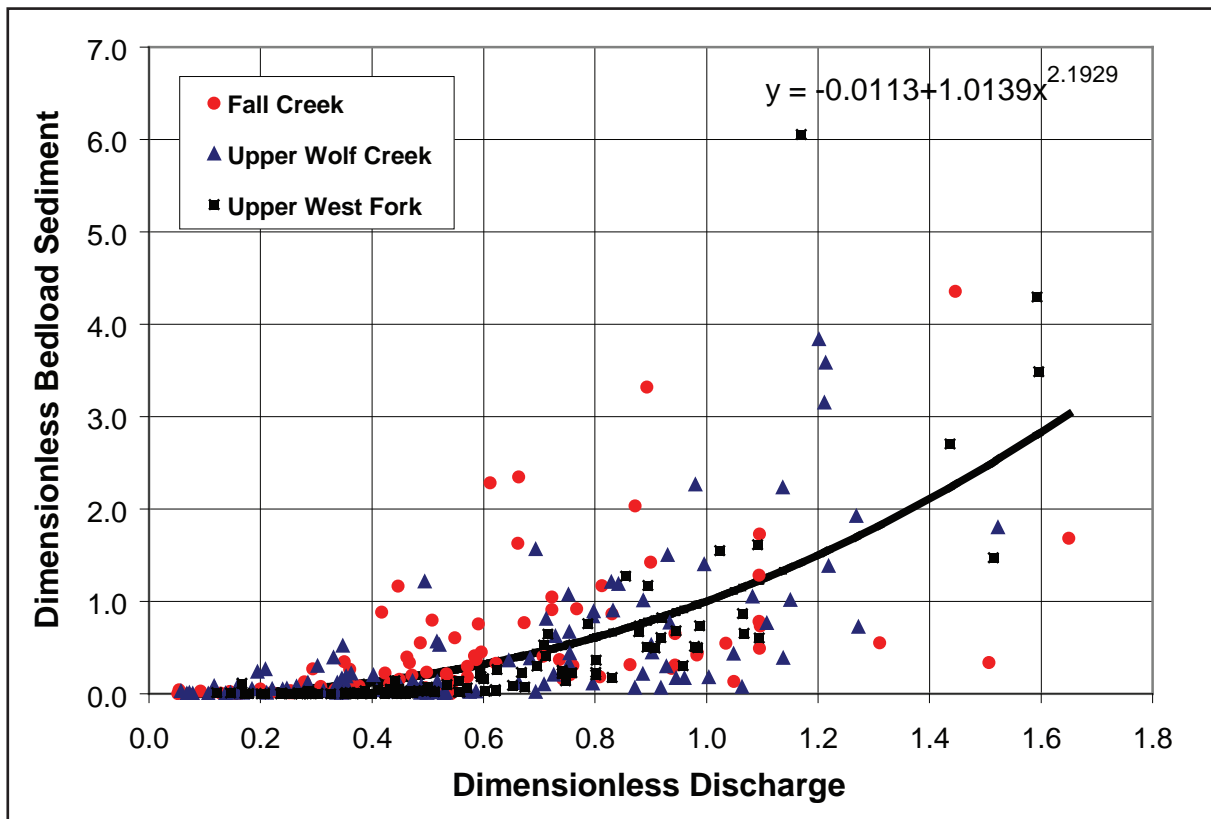
**Figure 42.** Dimensionless bedload sediment rating curves for “Good” and “Fair” stability streams derived from three streams in Pagosa Springs, Colorado.

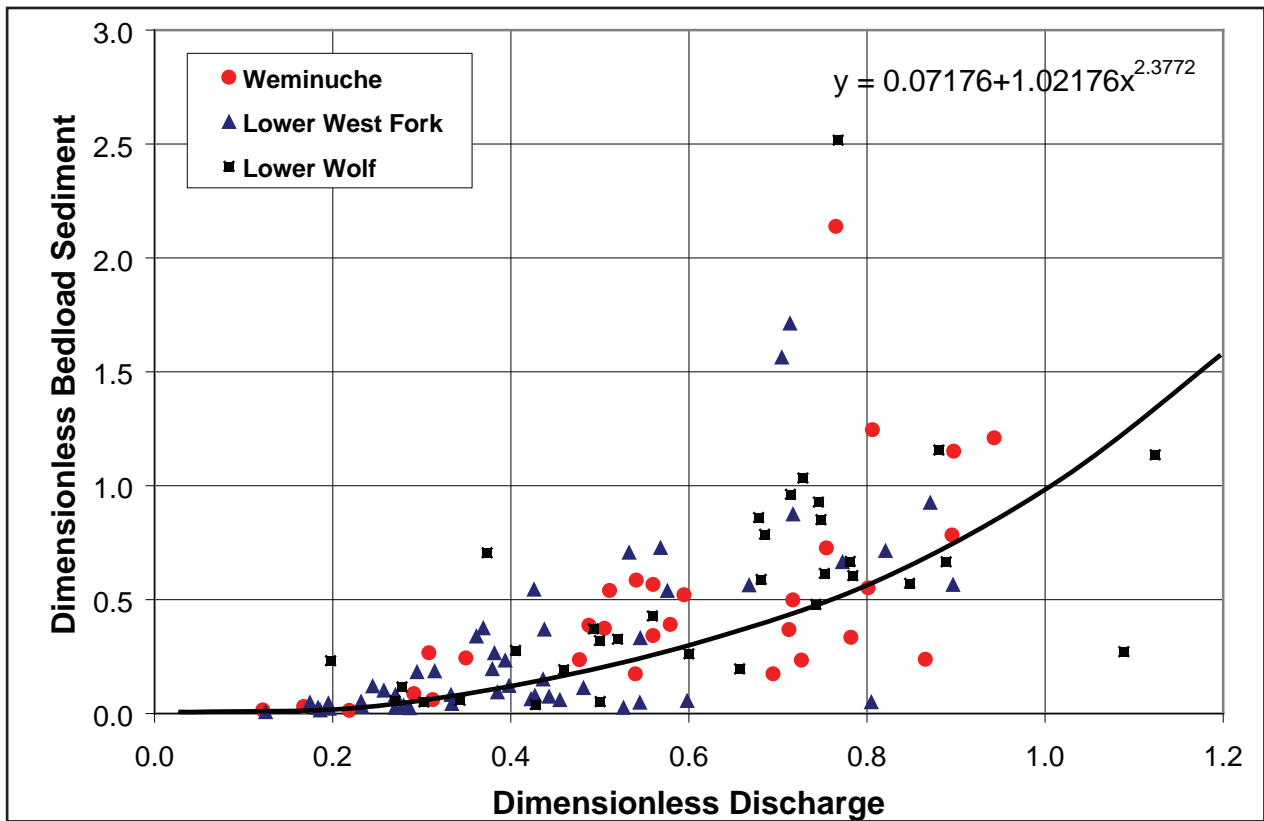
**Figure 44.** Dimensionless bedload sediment rating curves for “Poor” stability streams derived from three streams in Pagosa Springs, Colorado.

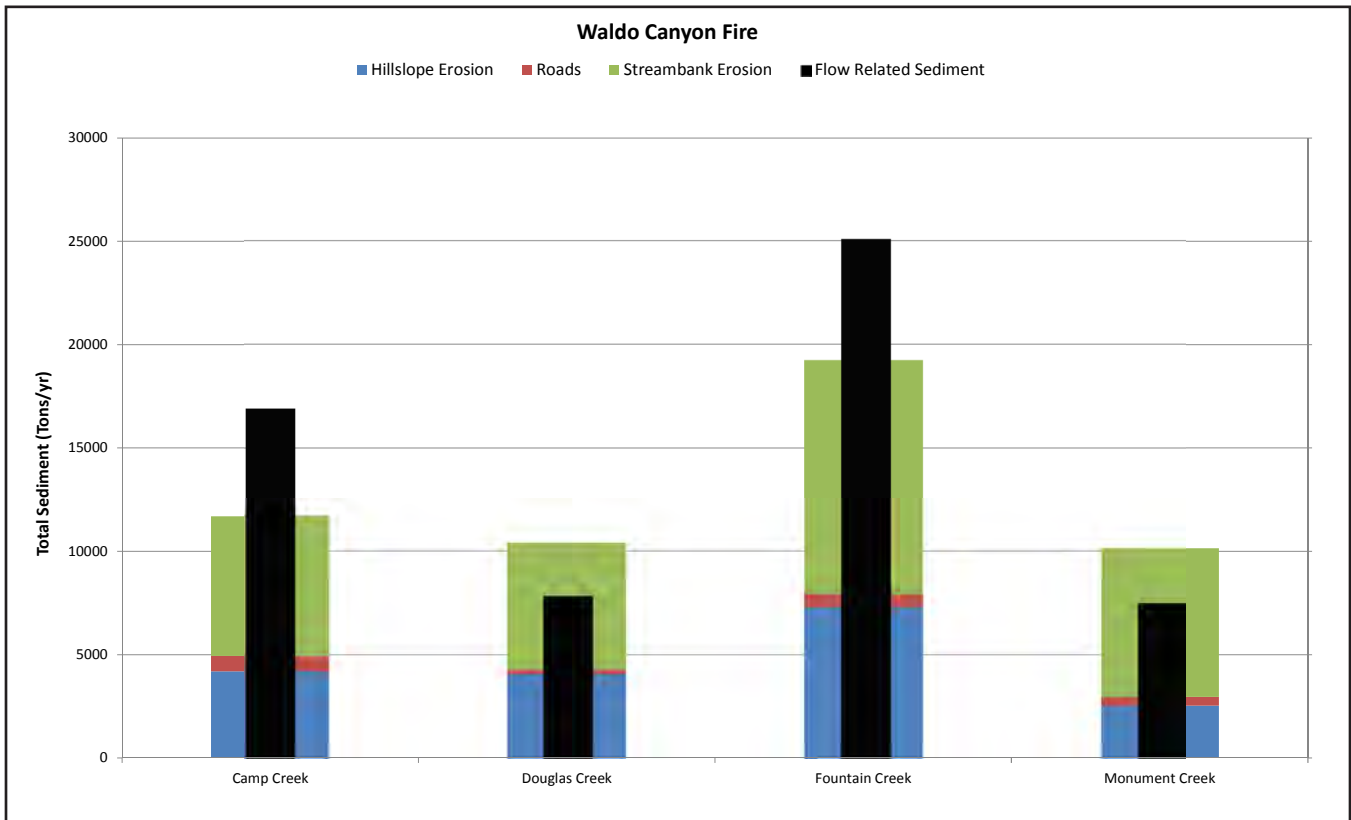
**Figure 50.** Relative amount of sediment contribution by process for the four major watersheds.

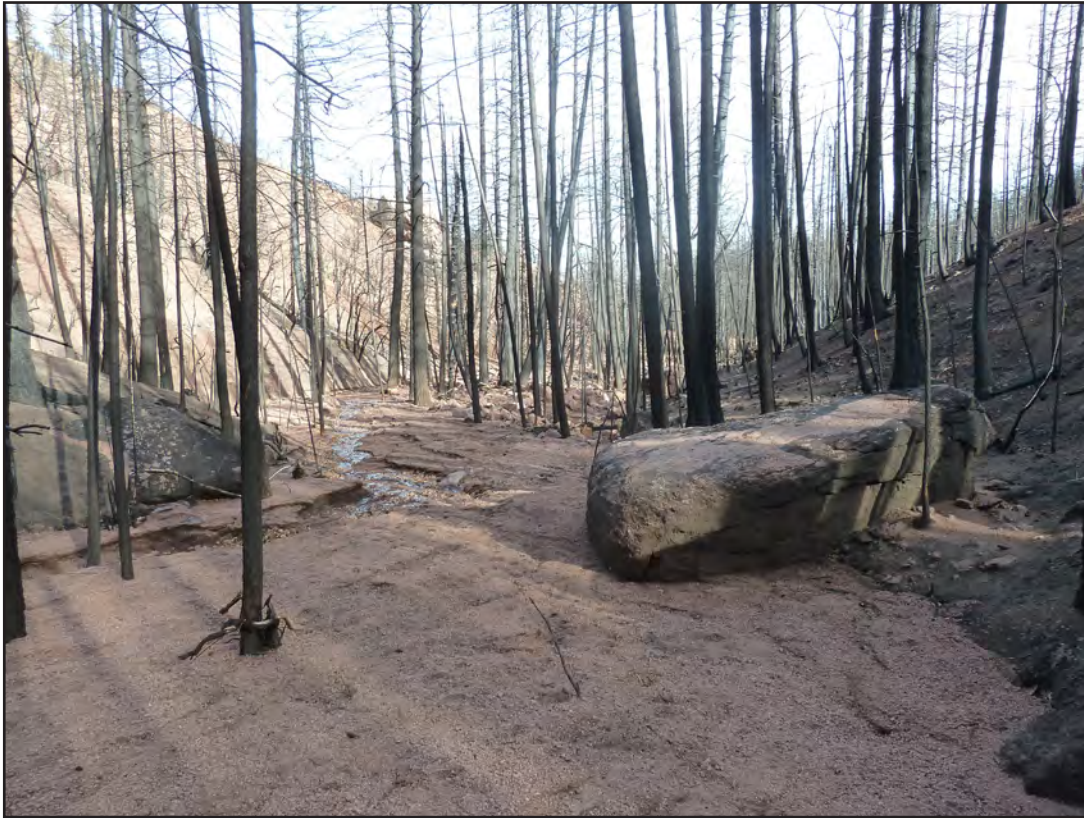
**Figure 51.** A headward-advancing G4 stream type in the Douglas Creek Watershed (DC-007) shifting to an F4 stream type due to excessive deposition and the easily-mobilized bed material (grussic granite).

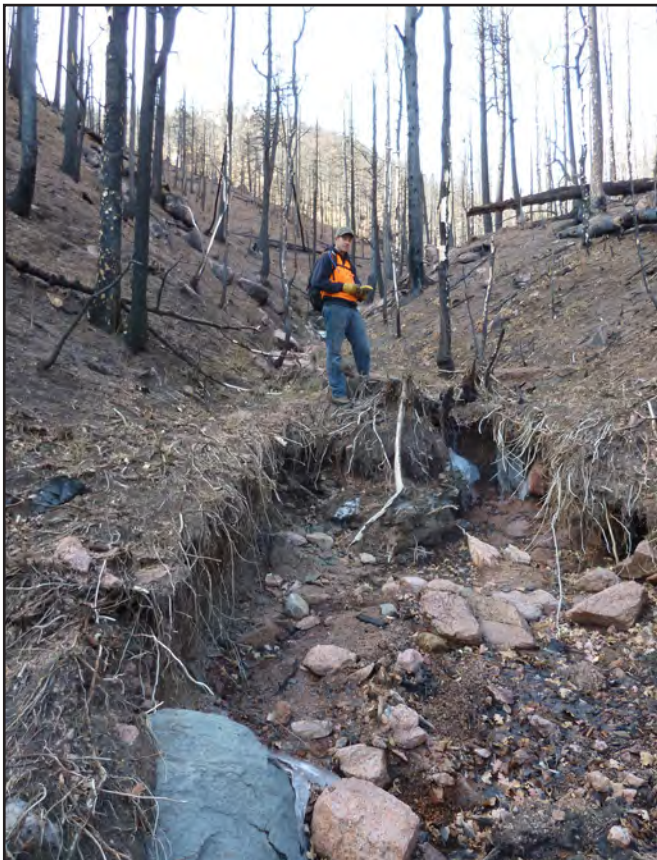
**Figure 52.** The lowering of a stream in the Douglas Creek Watershed (DC-007) caused by a base-level drop that accelerated the headward advancement (incision process) of a tributary on an alluvial fan.

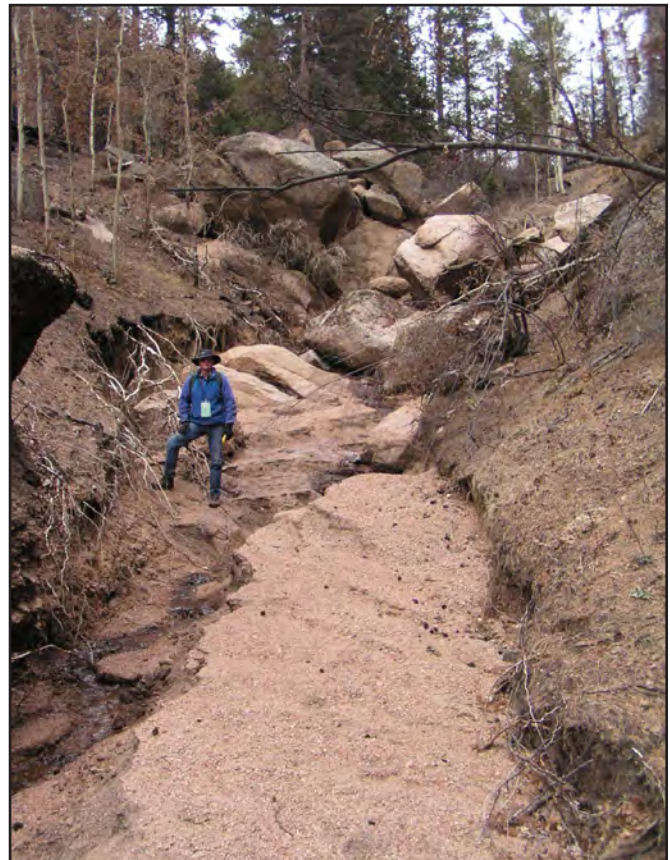
**Figure 53.** A very high sediment supply, high energy F4b stream type in Fountain Creek with evident streambank and streambed instability.

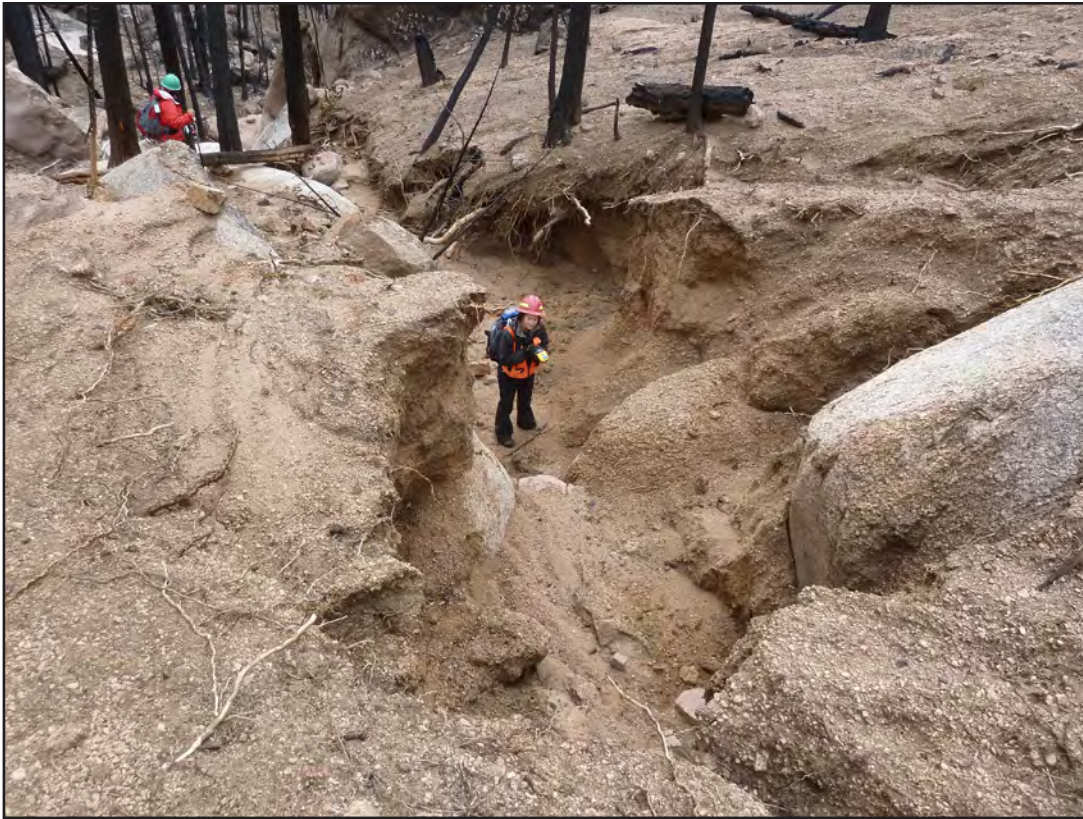
**Figure 54.** Excessive channel downcutting, which provides an unlimited sediment supply, Sand Gulch in the Fountain Creek Watershed (FC-011).

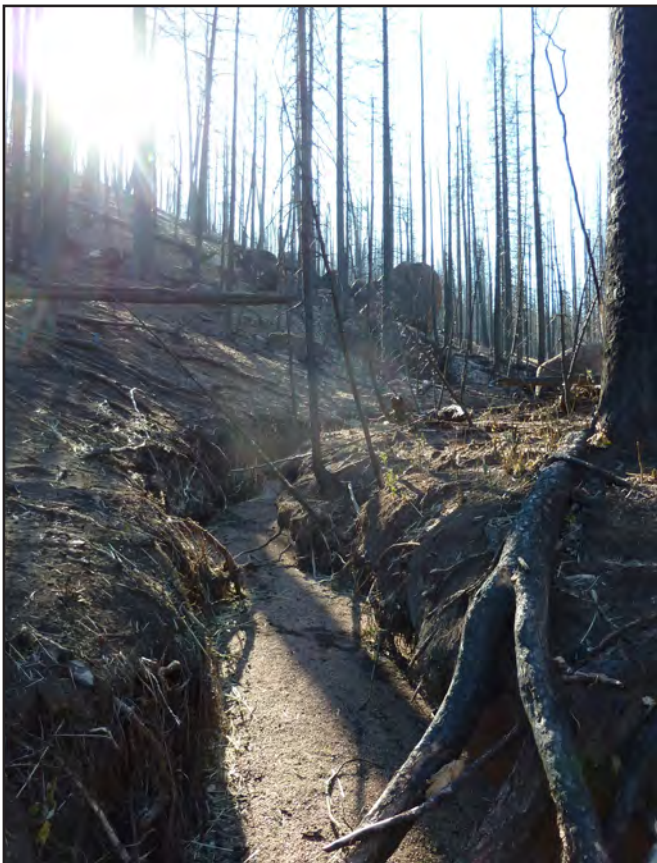
**Figure 55.** A downcutting G4 stream type in West Monument Creek (MC-010).

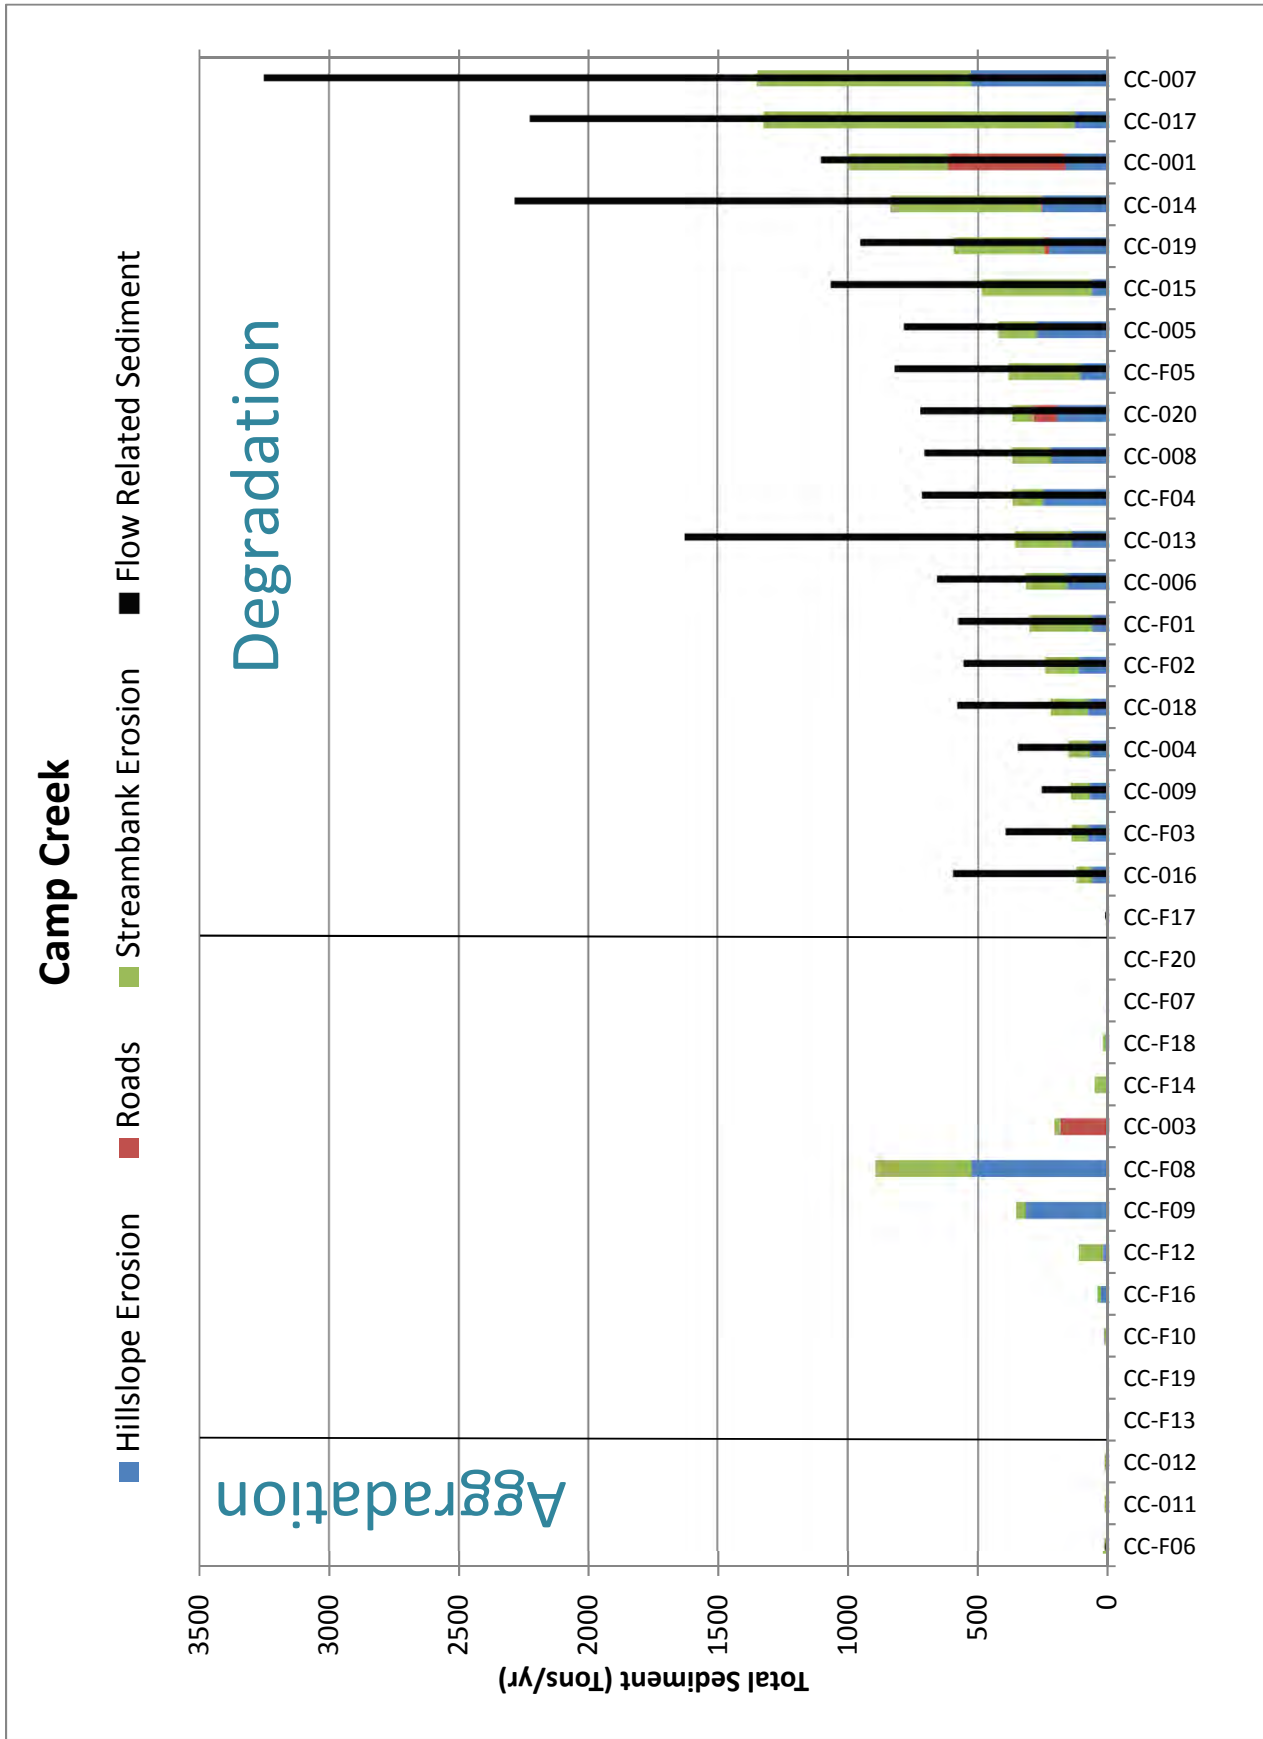
Figure 56. The potential of the Camp Creek sub-watersheds for aggradation / degradation.

In Camp Creek, 36 sub-watersheds (5,526 acres) were evaluated. Of the total watershed area, 78% burned (36% low intensity, 37% moderate intensity, and 5% high intensity) resulting in an average annual change in water yield of 2.6 inches, the second greatest change in water yield (**Table 3** and **Appendix A1**). For a detailed description of the burn effects on vegetative cover, see **Appendix A2**. The total amount of estimated introduced sediment from Camp Creek is 11,694 tons/yr, the second highest producer of the four major watersheds, with 58% from streambank erosion, 36% from hillslopes, and 6% from roads (**Table 14**). The FLOWSED model predicts 16,897 tons/yr of flow-related sediment, resulting in a potential net degradation (scour) of 5,203 tons/yr (**Table 13** and **Table 14**), equivalent to 3,251 yds<sup>3</sup>/yr, or 325 10-yard, end-dump truck loads per year. This value represents the average condition over the 36 sub-watersheds but does not imply that degradation occurs uniformly within the watershed or for every stream reach within the watershed. In fact, three of the 36 sub-drainages show a net potential aggradation, but Camp Creek is dominated by the 21 degrading sub-watersheds (**Figure 56**). The sub-watersheds on the left side in **Figure 56** show net aggradation (plotted in descending order of total introduced sediment), the sub-watersheds on the right side show net degradation (plotted in ascending order of total introduced sediment), and those in the middle are face drainages where the FLOWSED model was not applied. Sub-watershed CC-007 is the highest sediment producer and shows the most degradation at 1,901 tons/yr. Sub-watersheds CC-F06, CC-011, and CC-012 show a net aggradation of 16 tons/yr, cumulatively. Streambank erosion is the dominant sediment delivery process in most sub-watersheds. Road and trail sediment processes dominate in two sub-watersheds (CC-001 and CC-003) with significant contributions in just two others, CC-020 and CC-019. Hillslope erosion is the major process delivering sediment to just six of the 36 sub-watersheds. Sub-watersheds CC-F04 and CC-006 have the highest estimates of introduced sediment per unit area in the Camp Creek drainage at 4.5 and 4.3 tons/acre/yr, respectively.
