## *Appendix D*

# **Watershed Summaries**

## Waldo Canyon Major Watershed & Sub-Watershed Summaries

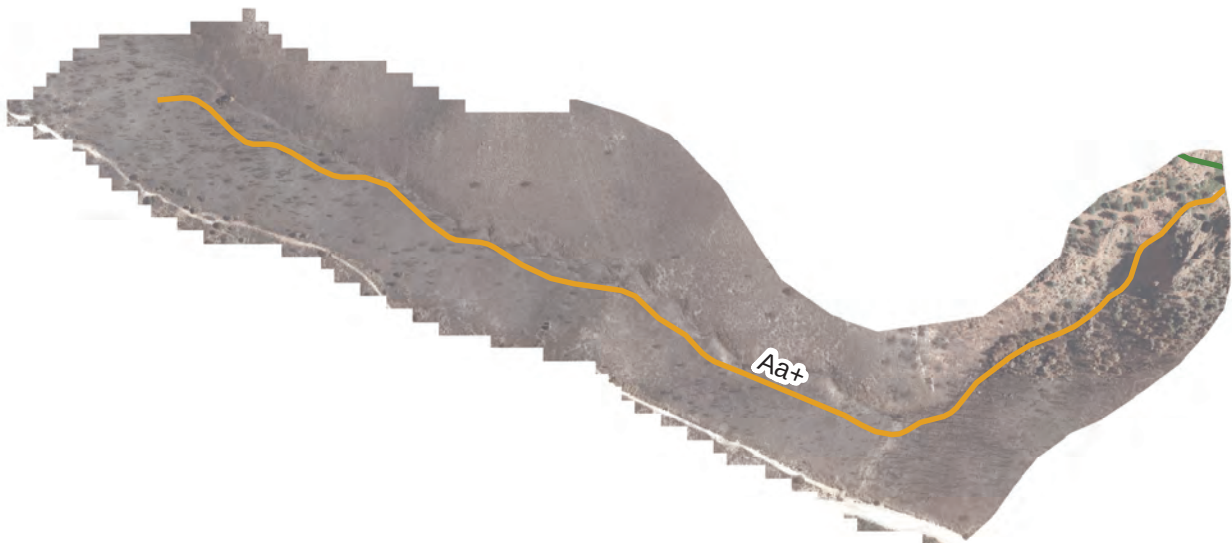
**CC-004**

**Stream Condition**

- Good
- Fair
- Fair-Poor
- Poor

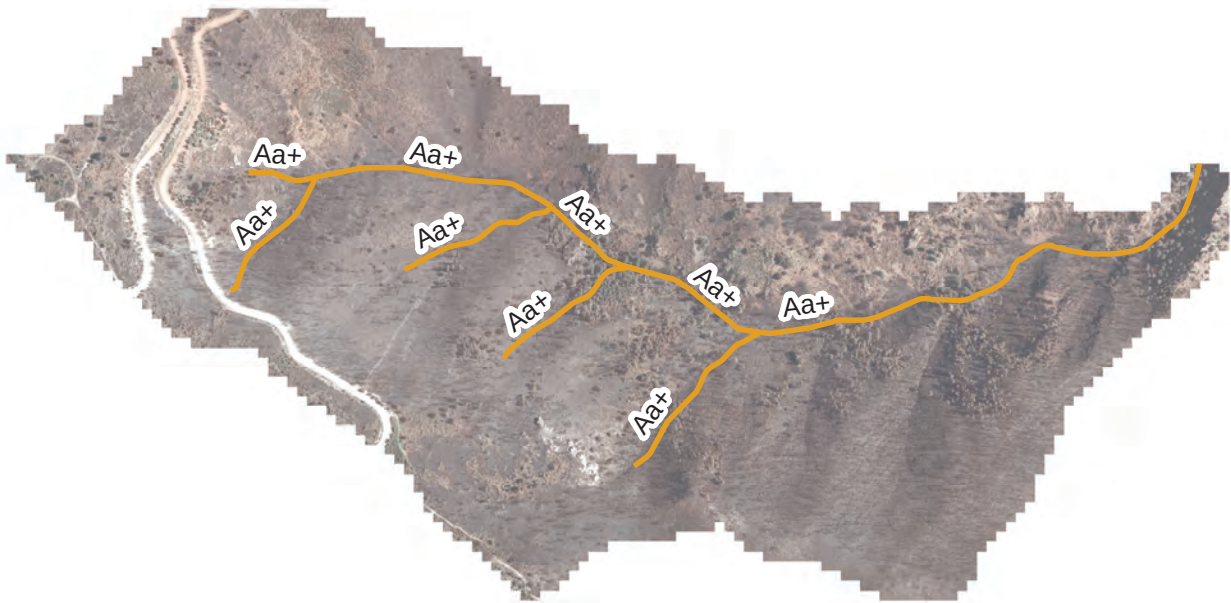
# CC-005

## Stream Condition

- Good
- Fair
- Fair-Poor
- Poor

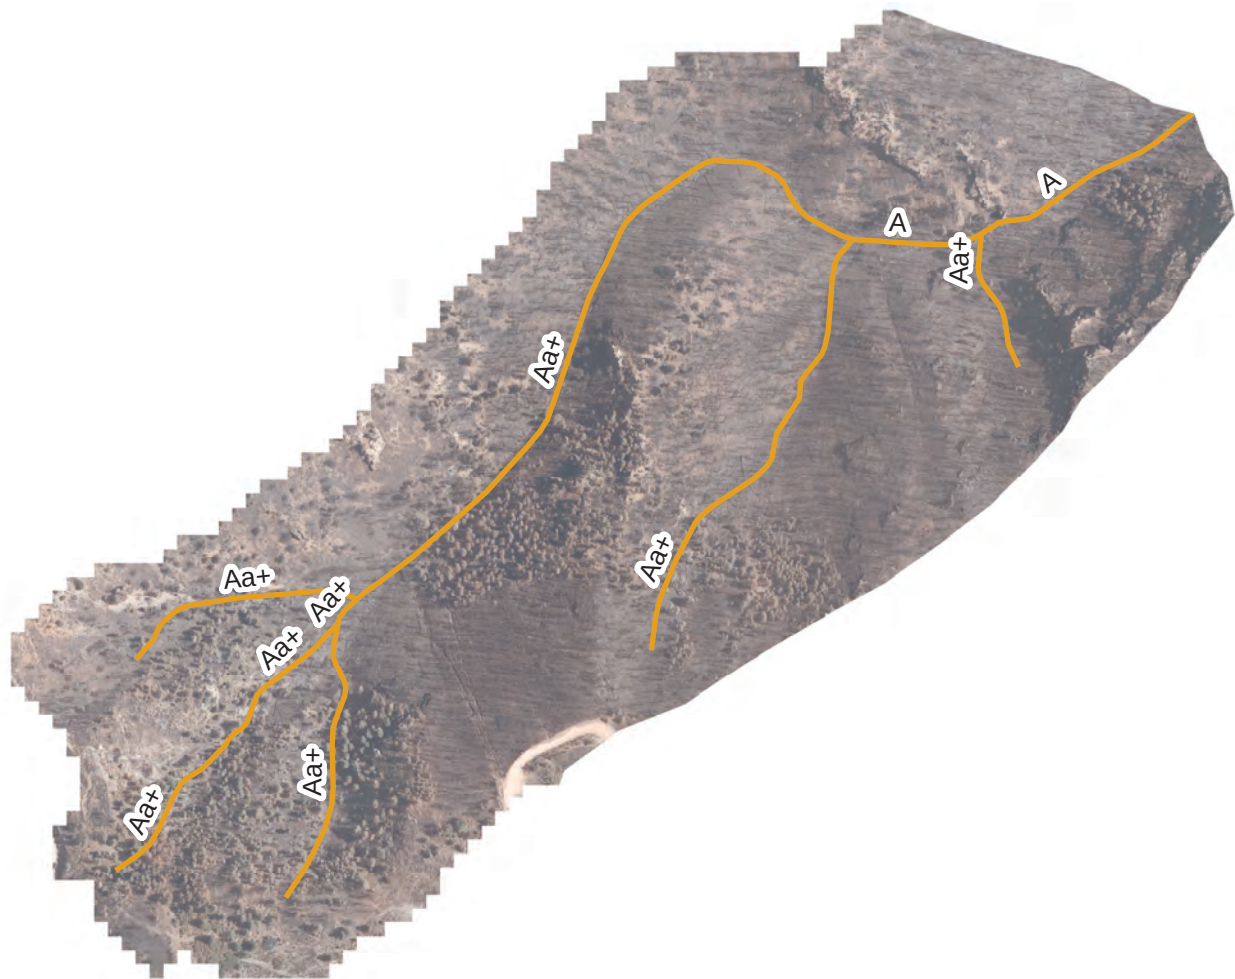
**CC-006**

**Stream Condition**

- Good
- Fair
- Fair-Poor
- Poor

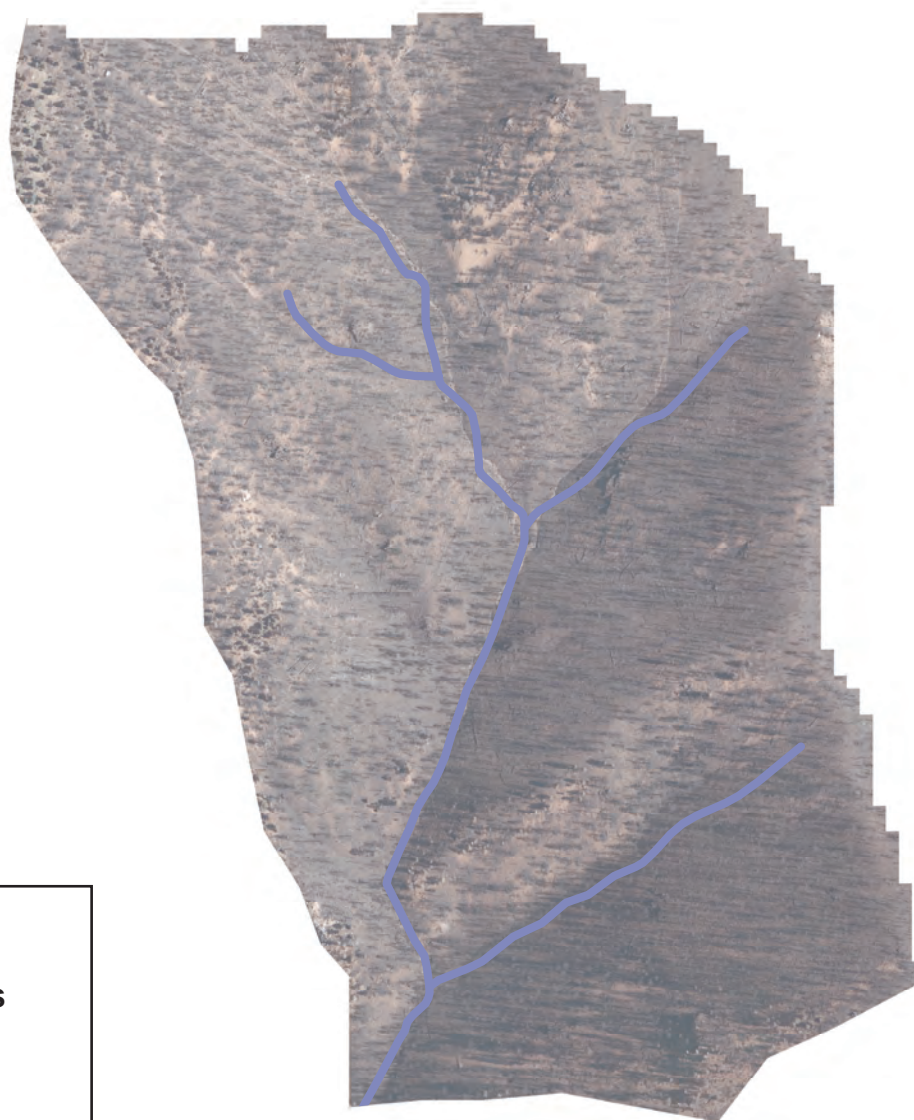
# CC-008

## Legend

### Erosion Rates Tons/Ft/Year

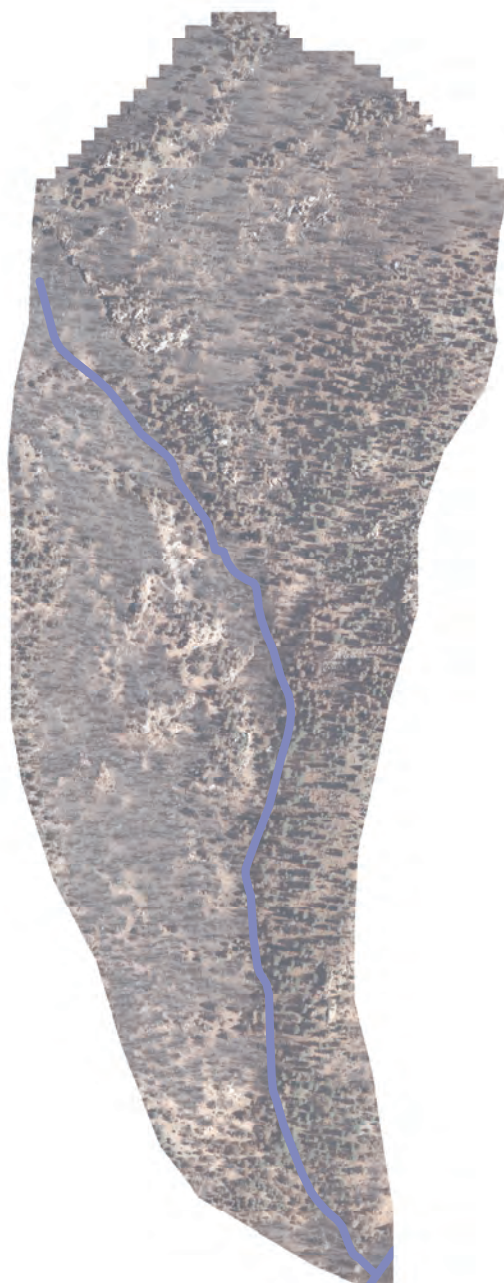
## CC-009

### Erosion Rates Tons/Ft/Year

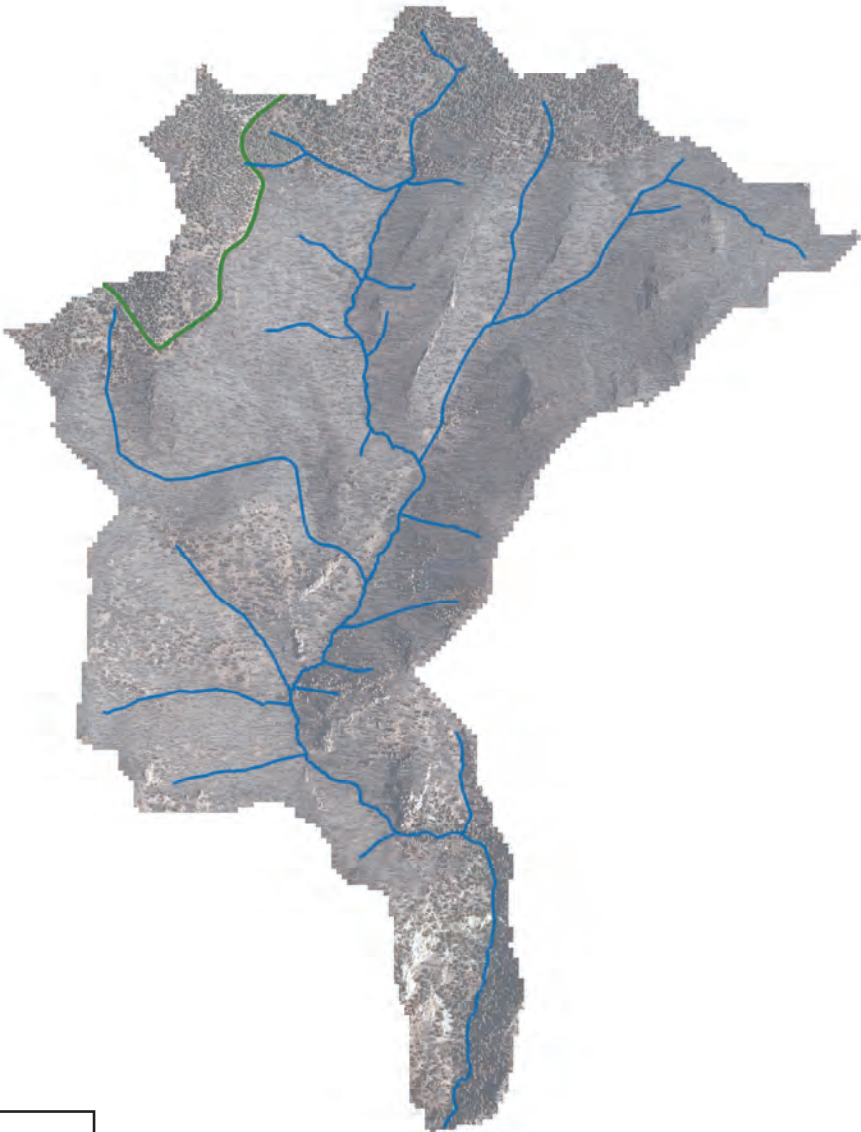
**Road Surface**  
**Road Surface**

Dirt

Trail

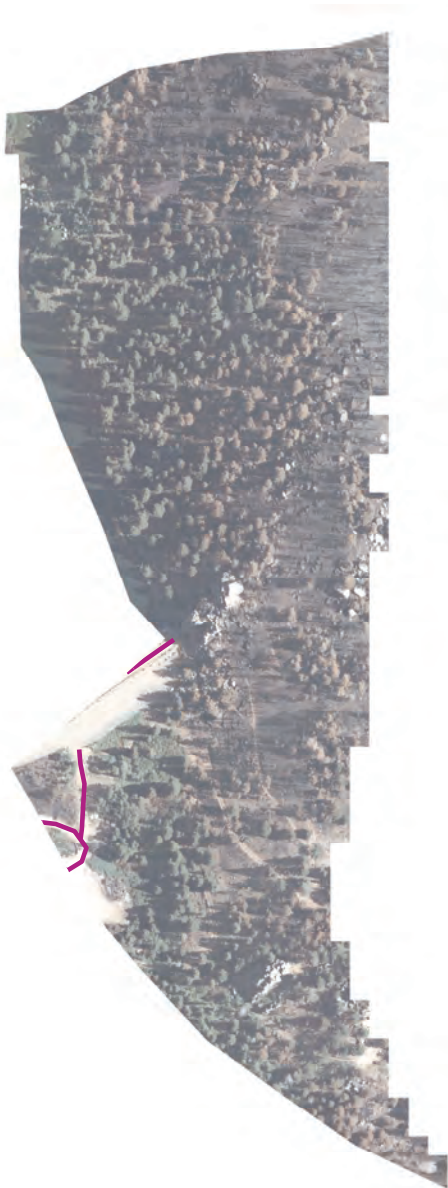
# CC-F19

**Road Surface**

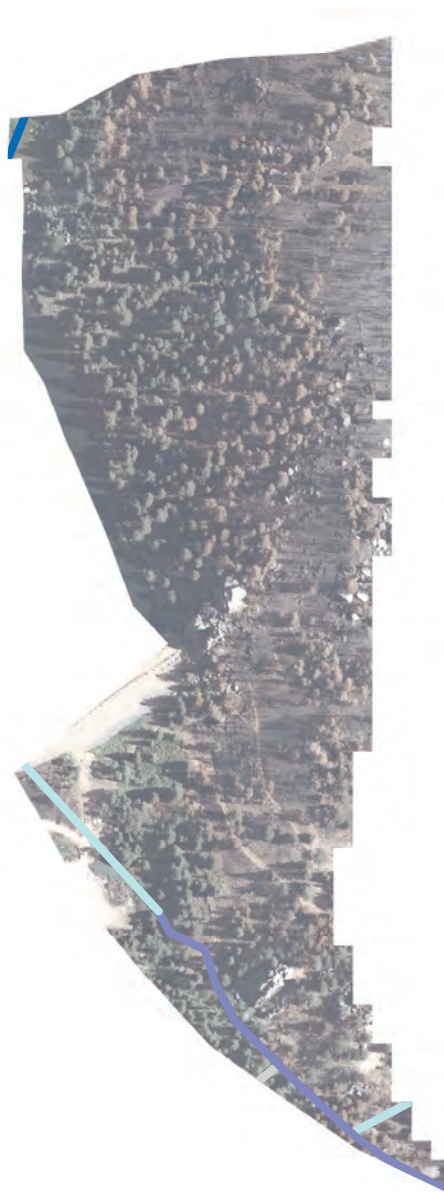
## CC-F19

### Erosion Rates Tons/Ft/Year

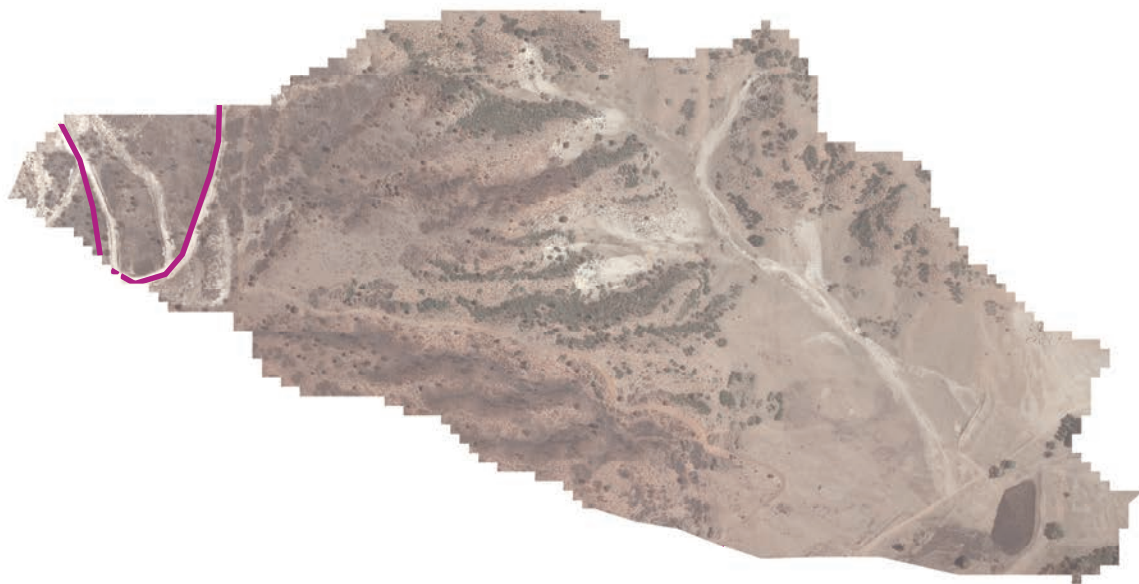
## DC-005

### Road Surface

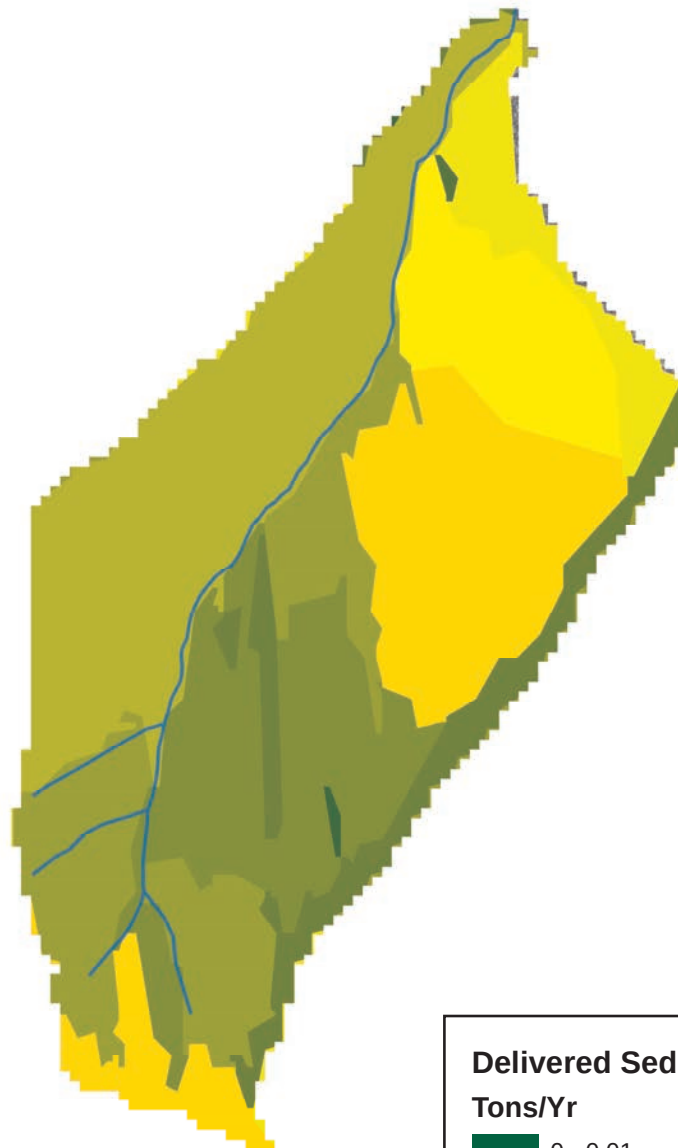
# MC-006

| Delivered Sediment | |

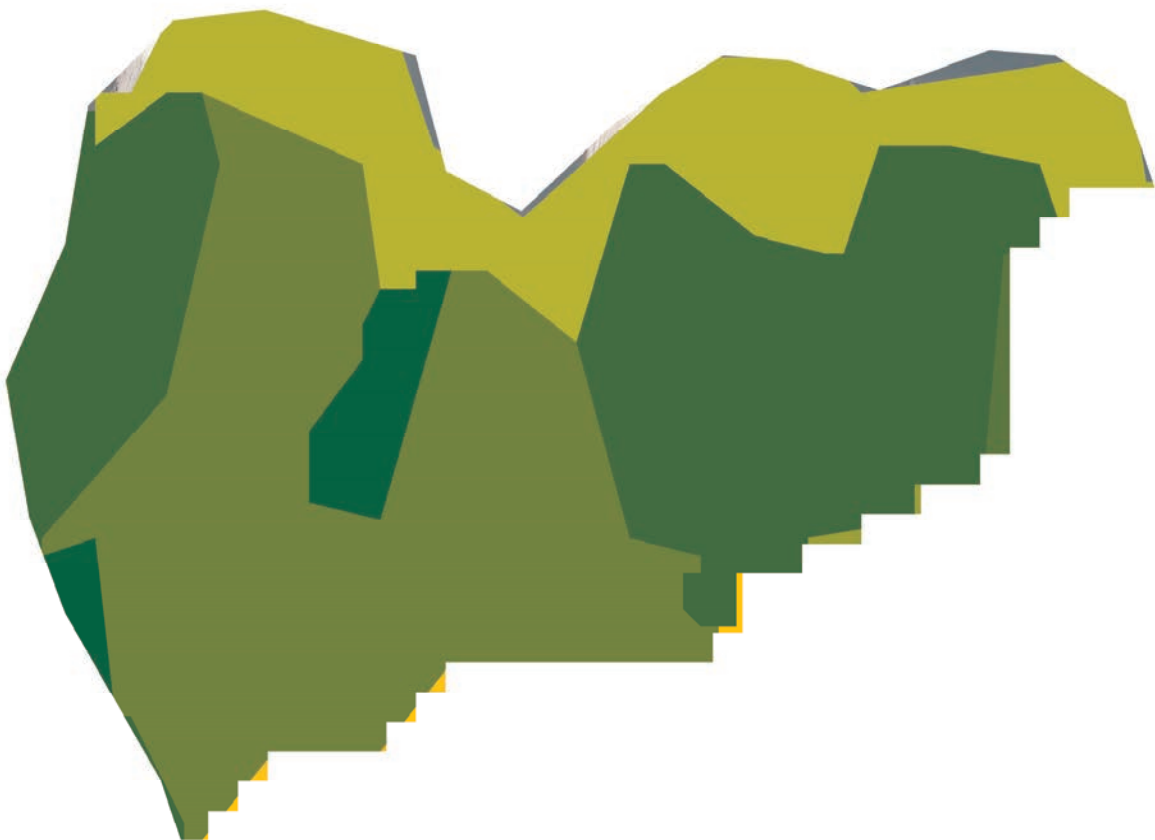
**MC-F10**

**Monument Creek, Sub-Watershed F10 (MC-F10)**

| Watershed Summary | | Stream: Monument Creek | | Sub-Watershed: MC-F10 | | | | | | | | |
| | | | Burn Severity (%) | 7.0% | 30.0% | 22.0% | 41.0% | | | | | |
| | Percent of Stream Conditions | | 0% | 0% | 0% | 0% | Total Erosion (tons/yr) | | 0 | | | |
